1046. Blades rubs and looseness detection in gas turbines – operational field experience and laboratory study

Leong M. S.¹, Lim Meng Hee²

¹Institute of Noise & Vibration, Universiti Teknologi Malaysia, Malaysia

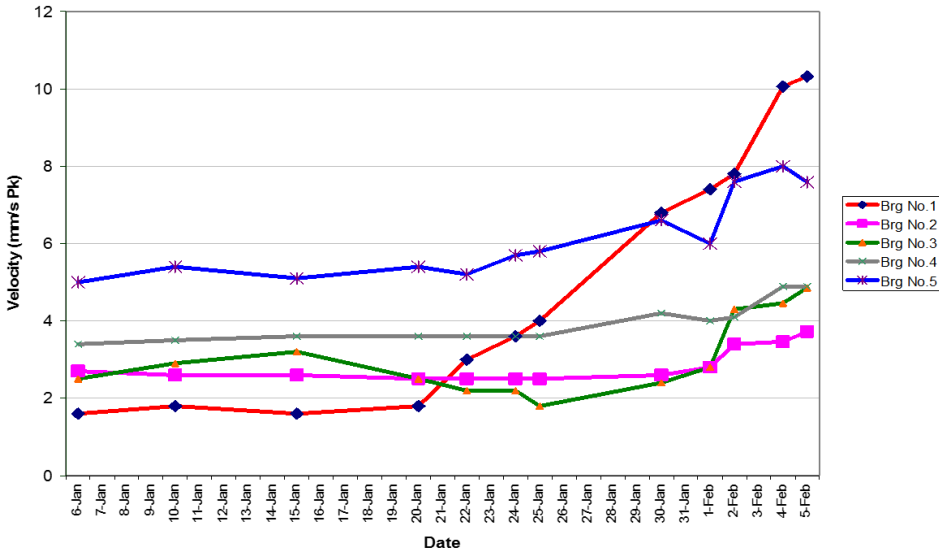
Fig. 2 shows trends of the x1 synchronous component for bearing casings in vertical direction over a month time span leading to the impending failure. Bearing (Brg.) No. 1 (compressor non-drive end), No. 3 (turbine drive end) showed marked increase over the latter two weeks period. Vibration levels in the four months period prior to this were less than 1 mm/s for bearings No. 1 and 3, and 3.3 mm/s for bearing No. 5 (generator non-drive end). The alarm limit was 12 mm/s and trip level at 25 mm/s (0-Pk). The synchronous amplitude and phase angle plots with speed

Fig. 2. Casing overall vibration levels as a cracked shaft was developing

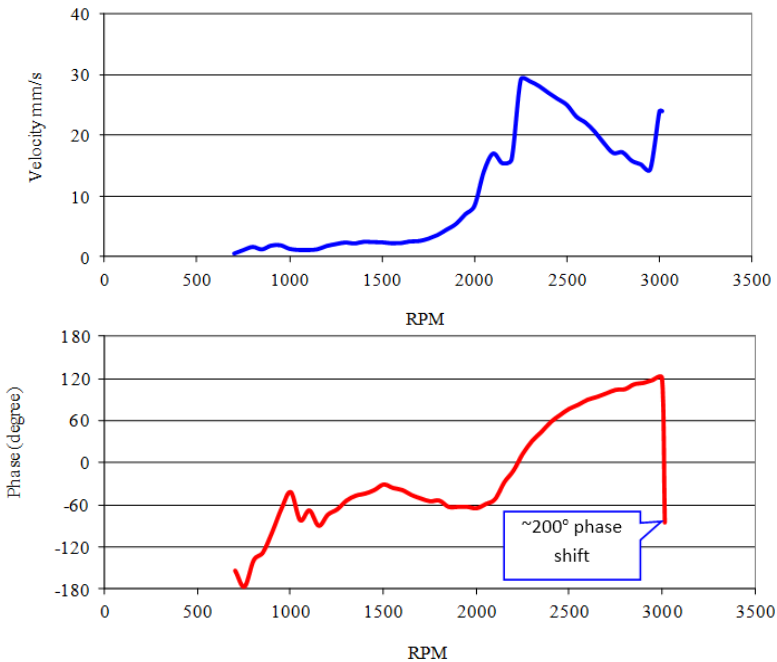
Fig. 3. Run up vibration amplitude (x1 RPM) and phase angles vs. RPM

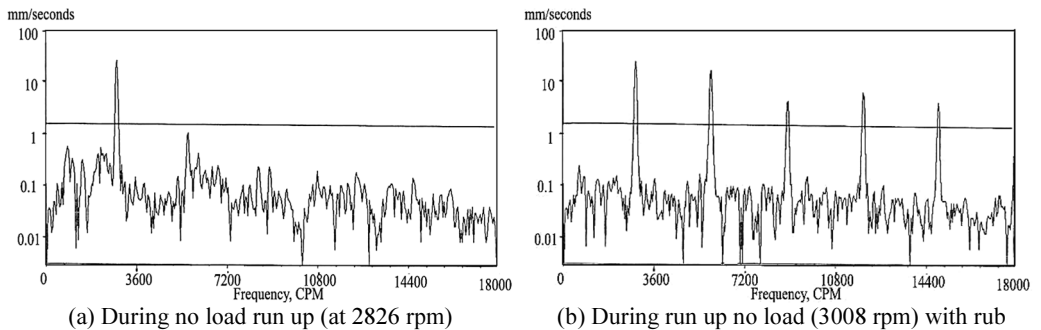
The vibration spectra during the run up past the first critical speed until the second critical speed were dominated by the synchronous x1 RPM component (see Fig. 4a). Vibration amplitudes however increased substantially as the second critical of 2280 rpm was approached. At this stage, high harmonics of x2, x3 and x4 rpm were noted (Fig. 4b). This suggested a rotor rub at the second critical had occurred due to excessive amplification at the second critical speed. After passing the second critical, vibration levels dropped with less prominent harmonic components. This

suggested the rub being relieved at this point in time. As the unit approached full speed no load (FSNL) conditions at ~3000 rpm vibration levels were below the trip limit.

Fig. 4. Vibration spectrum during run up (before and rub)

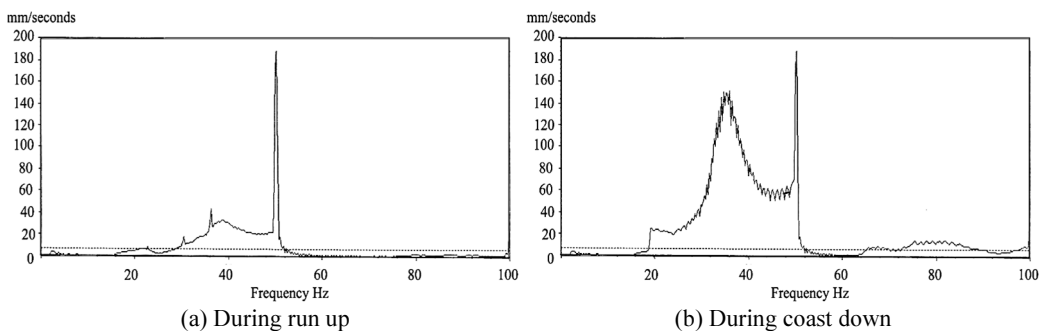
During the coast down, the dynamic amplification at the second critical was more severe as compared to the run up; Fig. 5a and b. The vibration response in the vertical directions was significantly higher than response in the horizontal direction particularly in the compressor NDE (Brg. 1) and turbine DE bearings (Brg. 3). A cracked shaft and/or thermally bent shaft were suspected to the root cause of the increasing vibrations particularly at the compressor bearing. A full rub was thought to have occurred as the unit passes through the second critical, with further development of a thermal bent shaft aggravating the problem which explained the severe excursion.

Fig. 5. Peak hold spectra during run up and coast down after a rub (bearing 1 vertical)

A subsequent run up investigation of the gas turbine was initiated by the plant with the generator uncoupled to isolate any fault from the generator. This run-up re-confirmed higher response in the vertical directions than the horizontal, with highest response at the compressor bearing. The unit was removed for an inspection where a 100 mm longitudinal crack was found in the compressor section, together with signs of severe rubs on the compressor blades. This resulted in a downtime of more than 8 months awaiting a replacement shaft at a time when there was almost no spare capacity in the national grid.

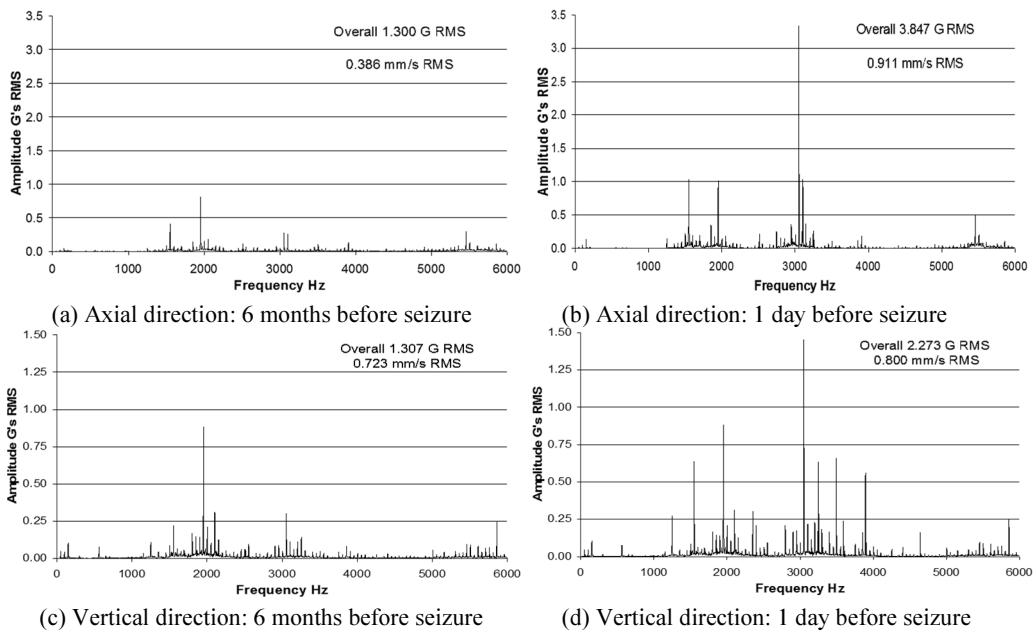
Fig. 6. Acceleration spectrum as measured on bearing 6 months and 1 day before shaft seizure

Typical vibration spectra on the generator drive end bearing casing undertaken six months earlier are given in Fig. 6a and c. Vibration spectra at the same location under suspected fault condition are given in Fig. 6b and d. Comparison of the spectrum showed distinct increase in specific blade passing frequencies (BPF), and with increased side bands of the BPF at intervals of the synchronous rpm. BPF at 3050 Hz, 3250 Hz, 3850 Hz and 3900 Hz were exceptionally high in vertical axis. Measurements in axial axis showed that the BPF of 3050 Hz was extraordinary high. Multiple harmonics of 3400 Hz, 3500 Hz, and 3600 Hz were also noticeable. The BPF of 3050 Hz (corresponding to compressor blades row 11, 12 and 14) in the vertical and axial directions showed increase with standard deviations as high as 13 times. For BPF of 3250 Hz (row 13), an equally high amplitude exceeding 28x standard deviations was noted. Other BPF of 3850 Hz (row 15-21) and 3900 Hz (stator blades row 15-20) also increased above 7x standard deviation. Trends of the BPFs are shown in Fig. 7.

Correlated with the physical evidence of reduced coast down time (which was obviously a strong indicator of increased friction i.e. rub) and with an audible rubbing sound, it was suspected that there were blade rubs. It should in fact be concluded with sufficient confidence that blade faults had occurred in the latter rows of compressor section of GT4.

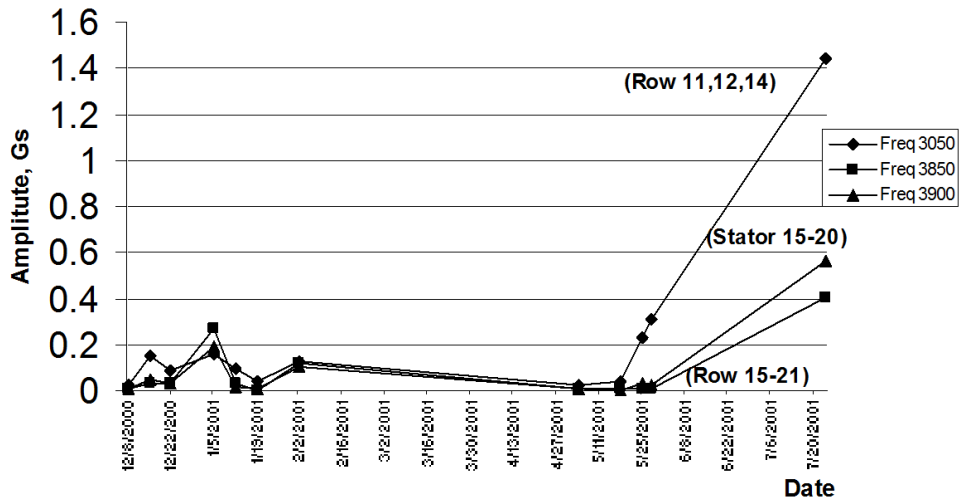
Fig. 7. Trending of selected blade pass frequencies

The extremely high BPF implied that the clearance between the rotor with stator and casing on these rows had been reduced. This was consistent with published works of Kubiak et al. [14] that reported that if the BPF had increased significantly in the vibration spectrum, blade rubbing could probably be present. The multiple harmonics noticed around 3400 Hz to 3600 Hz (which is not the BPF) in the vibration spectrums provided further evidence of rubbing. The rubbing between the rotor and stationary components could generate excessive localized heat and potentially causing the rotor to bow. A bowed rotor could further increase the rubbing. This explained the rotor seizure.

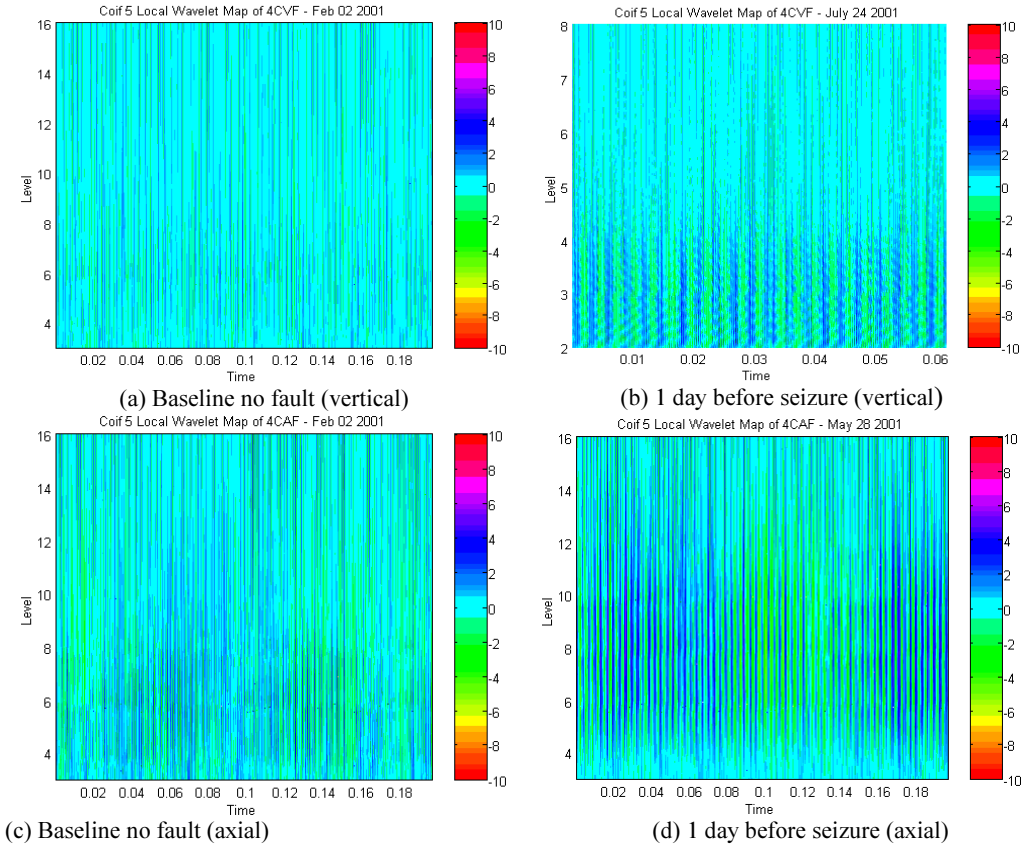
Extending the BPF analysis for the blade rubs, wavelet maps were also derived using time series data of the same measurements. The wavelet maps for the case prior (to fully developed fault) and during rub conditions are shown in Fig. 8 below. The wavelet maps under blade rub conditions did demonstrate noticeable changes.

Fig. 8. Local wavelet at time of increased BPFs leading up to shaft seizure
