Vibration diagnostics of small hydroelectric power station machinery

Abstract. This short paper describes a problematic of a small hydroelectric power station machinery vibration diagnostics. The vibration diagnostics of a power station machinery is very specific, machinery contains many possible damaged rotating parts including a turbine rotor. Non-stationary strength pulsing caused by water flow can be generated. The paper describes problems with the correct determination of a small hydroelectric power station machinery failure.

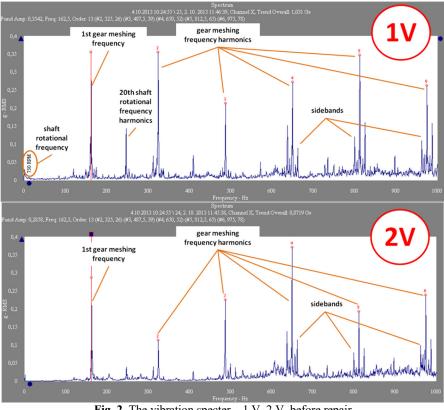
Fig. 2. The vibration specter -1 V, 2 V, before repair

The gearbox damage was evident and the repair was necessary. The one of the main friction

bearing of input shaft was damage. The damage was define by the generated harmonic and interharmonics rotor frequencies. The gear frequency modulation was diagnostic, the gear could be damaged too. The main vibration specter abnormalities are shown on the Fig. 2 where the vibration specters measured near of gearbox shaft housing (places 1 V, 2 V) are depict.

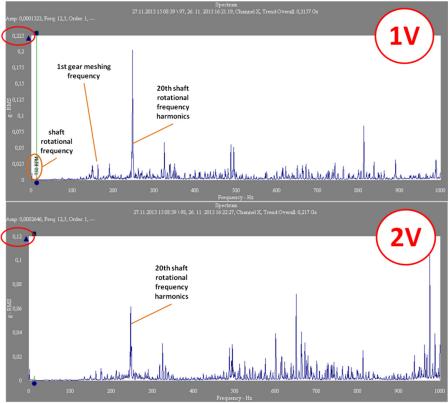
The second comparing vibration measurement after the bearing repair was performed. The vibration specters are on Fig. 3.

Fig. 3. The vibration specter -1 V, 2 V - after repair

The maximal measured acceleration values are in Table 1. Table 1 compares the values before and after the repair. The maximal acceleration value after repair are more than 60 % lower than before. The gearbox was labeled as a "class A" (according standard ČSN ISO 10 816-1) after the repair- perfect condition and a long service life.
