Failure analysis of gas pipeline in a gas collecting station

Abstract. The gas collecting line of a gas collecting station failed and had obvious corrosion pits. The failure reasons of the pipeline in this section are studied by means of macroscopic morphology analysis, mechanical property analysis, hardness analysis and microstructure analysis. The results show that the main reason is the mechanical damage caused in the construction process for the damage of the anticorrosive coating on the outer surface of the pipe section. The main reason for the failure of “corrosion pit” inside the pipe section is that the wet gas transported contains CO₂, which dissolves in water to generate H₂CO₃, and the pipe section is corroded in H₂CO₃ solution by electrochemical corrosion, which gradually develops into a more serious corrosion pit. In order to prevent the occurrence of such failure, 13Cr (martensite) material can be used to meet the corrosion resistance requirements, but also can appropriately increase the gas temperature in the tube to reduce the solubility of CO₂ in water to prevent corrosion.

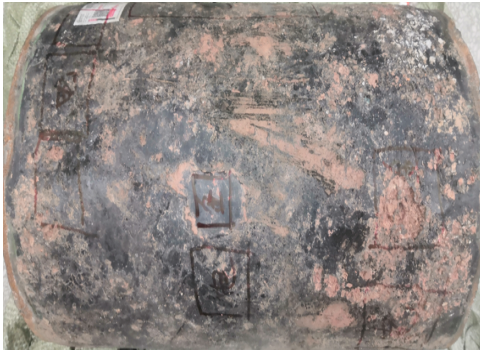
Fig. 1. Macroscopic appearance of sampling tube

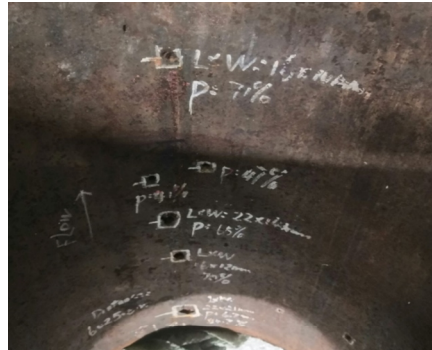
The macro morphology of the failed pipeline is shown in Fig. 1 and Fig. 2. It can be seen from Fig. 2 that there are 9 obvious corrosion pits on the inner wall of the tube sample. After cutting the relatively serious corrosion pits, the minimum remaining wall thickness of all the corrosion pits are measured to be 2.72 mm, 2.66 mm, and 2.36 mm, respectively.

Fig. 2. Macroscopic appearance of the inner surface of the tube sample

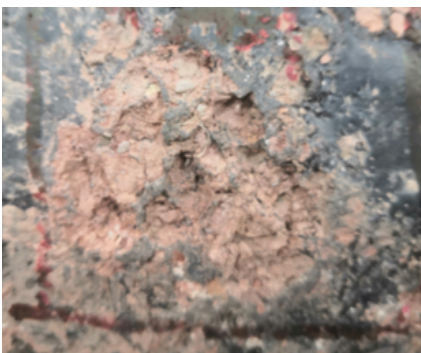
The anti-corrosion layer on the outer surface of the pipe sample is partially damaged, and part of the surface is stuck with a “soil layer with small gravel”. “Soil layer with small gravel” is stuck on the surface, as shown in Fig. 3. After clearing the “soil layer with small gravel”, it was found that the anti-corrosion layer on the outer surface of the pipe sample was not completely damaged. After the anti-corrosion layer was wore away, the metal outer surface of the pipe sample did not appear damaged or corroded (The surface rust appears after the anti-corrosion layer is worn away), as shown in Fig. 4. The anti-corrosion layer on the outer surface of the pipe section is damaged, and the local damage is serious and there is a “soil layer with small gravel”, but not completely penetrated the anti-corrosion layer, and there is no corrosion or rust on the outer surface of the pipe section. It is inferred that the main reason for the damage of the anti-corrosion layer on the outer surface of the pipe section may be the mechanical damage during the construction process.

Fig. 3. The serious pipe section with “soil layer with small stone slag” is adhered to the surface

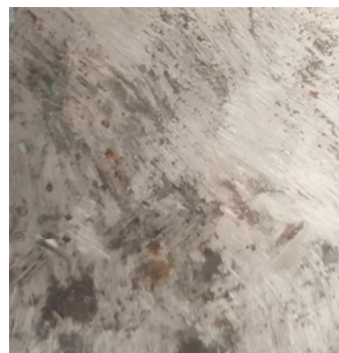
Fig. 4. The outer surface of the tube sample after the anticorrosion coating is worn off

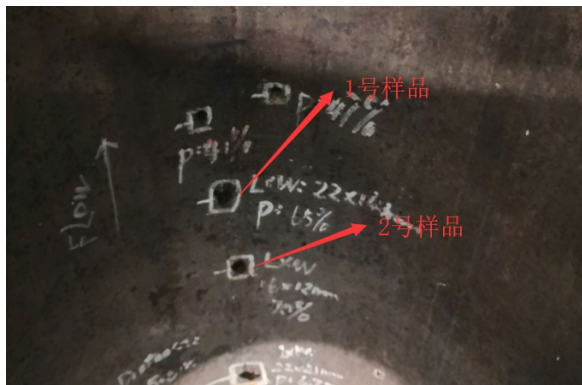
In order to improve the judgment of the microstructure condition, sample 1 and sample 2 are taken from the corrosion pits of the pipe section samples for structural analysis, as shown in Fig. 5. According to GB/T13298-1991 “Metal Microstructure Inspection Method”, the microstructures of the two samples are evaluated as ferrite plus pearlite, as shown in Fig. 6 and Fig. 7. According to GB/T 10561-2005 “Determination method of non-metallic inclusions in steel”, the non-metallic inclusions in the two samples are evaluated as D-type inclusions (spherical oxides), and the grade is 1.5; according to GB/T 6394-2002 “Method for the determination of the content of non-metallic inclusions in steel” to evaluate the grain size of the two samples, the measured grain size is 7 grades.

Fig. 5. Metallographic analysis of sample sampling location at low power

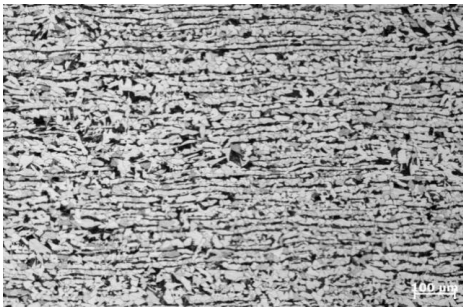
Fig. 6. Sample 1 metallographic photograph

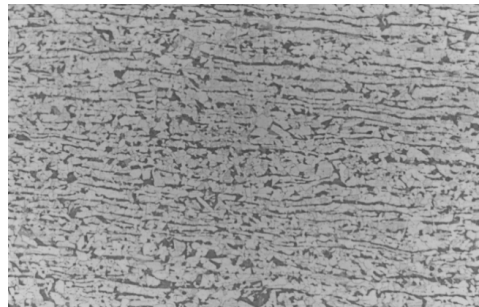
Fig. 7. Sample 2 metallographic photograph

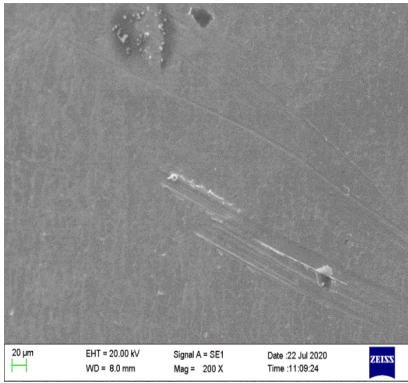
In order to understand the reason for the corrosion of the tube sample, sample 1 was intercepted in the non-corrosive area of the tube sample, and the results of scanning electron microscope and energy spectrum analysis were shown in Fig. 8 and Table 5. The results show that the surface of sample 2 is flat without any layered or massive corrosion products. Sample 1 is mainly Fe, C, O and a small amount of Si and Mn. Sample 2 was intercepted at the corrosion pit of the pipe sample, and the results of scanning electron microscopy and energy spectrum analysis were shown in Fig. 9 and Table 5. The results show that there are gray layered and massively distributed corrosion products in the pits on the inner surface of sample 1. The gray corrosion products at the bottom of the pits are mainly Fe, O, C and a small amount of Al, Si, P, S, and Mn. It shows that the corrosion type of the gas gathering pipeline is pitting corrosion. A block sample is taken from the pipe corrosion pit, and the corrosion product is analyzed for phase. The results show that the corrosion products are mainly FeCO_3 , Fe_3O_4 , FeO , $\text{FeO}(\text{OH})$.

Fig. 8. Morphology of uncorroded area of pipe sample

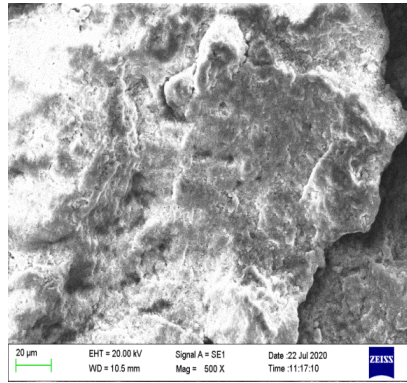
Fig. 9. The high-magnification morphology of corrosion pit

Excluding the possibility of sulfide and O_2 corrosion, combined with the XRD analysis results, it can be judged that the drill pipe corrosion is mainly caused by CO_2 corrosion. The gas collecting pipeline of this gas collecting station conveys wet gas. The CO_2 in the gas gathering pipeline is dissolved in water, which reduces the pH value of the water and becomes weakly acidic, forming the corrosion product FeCO_3 . CO_2 itself does not corrode the pipeline, but it is extremely corrosive to metal materials after being dissolved in water, and the corrosion of low-carbon alloy steel by CO_2 is mainly pitting corrosion [13-15].

1) In order to prevent the CO_2 corrosive environment from damaging the gas gathering pipeline, corrosion-resistant alloys are used as pipeline materials. According to related literature, nickel-based alloys and 22Cr have the best corrosion resistance, but they are not economical. 13Cr (Martensite) can be used. It can fully meet its corrosion resistance requirements.

2) Corrosion inhibitors can be injected into natural gas to alleviate metal corrosion, but corrosion inhibitors are not widely used. They may be effective in one area but not in another area. It is necessary to simulate the actual situation of the oil field before use. Various corrosion inhibitors are evaluated and screened under working conditions.
