# Failure analysis of gas turbine in first stage turbine blades in an urban power plant

Mohamed K. Hassan<sup>1</sup>, Waheeb M. Sindi<sup>2</sup>, Ahmed Mohamed<sup>3</sup>, Ahmed H. Backar<sup>4</sup>

<sup>1, 2, 3, 4</sup>Mechanical Engineering Department, College of Engineering and Architecture, Umm Al-Qura University, Makkah, Saudi Arabia

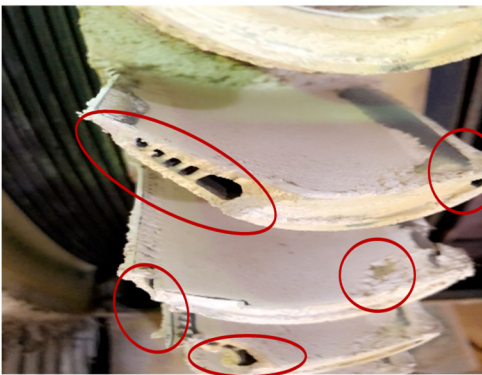
Fig. 8. Turbine blades missing body materials

During the fact-finding process, at 77,521 running hours, some of the turbine blades at the first stage discovered damage, missing elements from the blades body (see Figs. 8 and 9), and a thick layer of sulfuric acid (see Fig. 10) accumulated in the cooling airfoils of the blades. The blades were brand new, having been installed following HGPI at 42,000 running hours. This discovery explains the informality of the vibration, which was plainly visible in the trends during pre-outage data collecting.

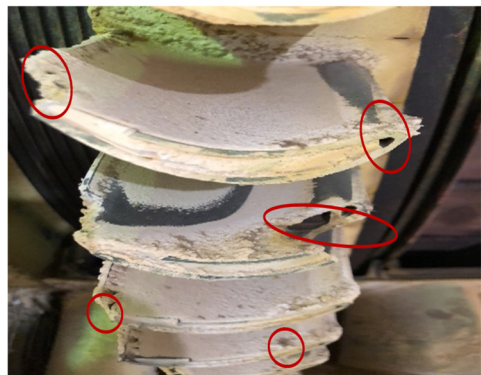
Fig. 9. Other turbine blades missing materials from both sides

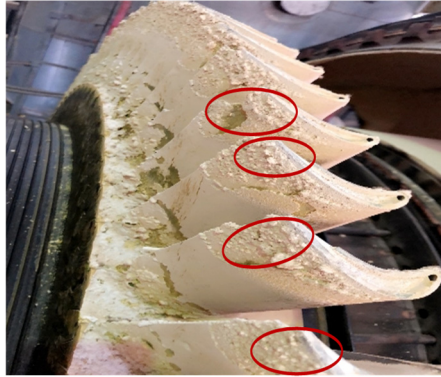
Fig. 10. Sulfuric acid casing corrosion erosion type. Also, accumulated and blocked the cooling air paths

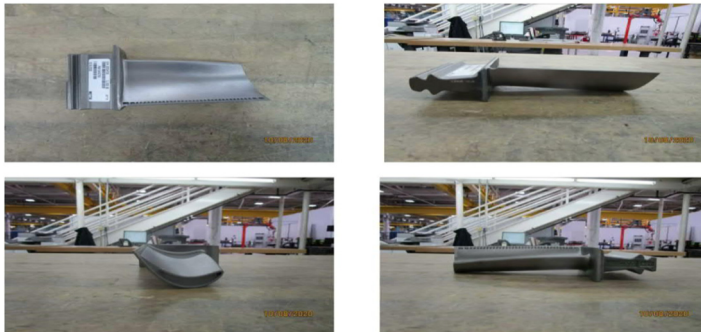
Group of 1st stage gas turbine blades (89SGT6 200E row 1) are employed to refurbishment and examples of these blades are shown in Fig. 11. During the incoming inspection process, sixty-four blades were found to have linear cracking in the blade airfoil that was beyond repair

limits and these blades were deemed unrepairable. Twenty-five blades were successfully processed through repair. All repaired blades were sent to the coating vendor and have been processed through final inspections and are acceptable for release to the customer.

Fig. 11. Group of 1st stage gas turbine blades (89SGT6 200E row 1)

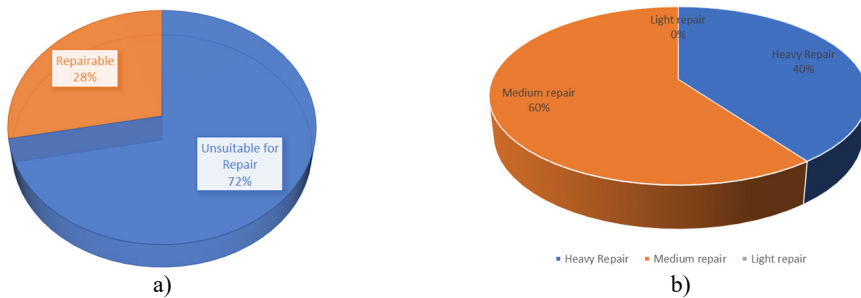
Fig. 12 depicts an overview of the repair process. Twenty-five blades are found to be repairable, accounting for 28 % of the investigated blades, whereas sixty-four blades, accounting for 72 % of the investigated blades, are unsuitable for repair. Ten of the twenty-five repairable blades require serious repair, while fifteen require light repair. There are no blades that require minimal repair.

Fig. 12. Overview of repair process. Percentage of a) repairable and b) Unsuitable for repair
