858. Structural health monitoring (SHM) for composite structure undergoing tensile and thermal testing

Abstract. Application of ultrasonic guided waves generated by piezoelectric smart transducers has become one of the widely-used techniques in structural health monitoring. This technique has led to significant improvements and profound effects in the field of aircraft reliability and safety. Lamb wave propagation on composite plate-like structure undergoing mechanical testing is investigated in the paper. Smart PZT actuator/sensor is bonded on the carbon-fiber and glass-fiber epoxy composites, which are subjected to tensile and thermal stress tests. The acquired results indicate the changes in scattering waves in composites materials due to the applied thermal and tensile force. Wavelet analysis was incorporated in this research work in order to distinguish different structural status.

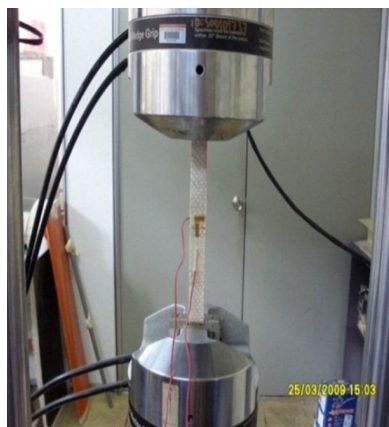
Fig. 2. Test specimen with MTS Machine

Tensile modulus and strength of the FGEP was measured in the longitudinal direction in accordance to ASTM D3039 [20]. The tensile specimens had a gage length of 250 mm and thickness of 3 mm. The test was performed using a MTS 100 kN machine at a constant rate of 2 mm/min. As the specimen experience the tension load, a deformation in specimen material will induce response. From the test, the strain data can be obtained and they are being determined from strain gauges attached directly to the specimen. Meanwhile, the integration of Testwork® software in the MTS Machine allowing the machine to record load distribution, displacements and time during the test. From all these data, dynamic stress-strain curve for specimen materials are determined and material behavior and properties under tensile load are described. Fig. 2 illustrates tensile test setup. The purpose of the strain gauge was to register the strain directly on

the specimen during the test. The operation of the strain gauge is based on the change of electrical resistance from the thin wire or piece of metal foil under strain. The sensor was bonded to the specimen in a specific direction. The wire and specimen shared the same strain thus, gave the reading momentarily when the load was applied.

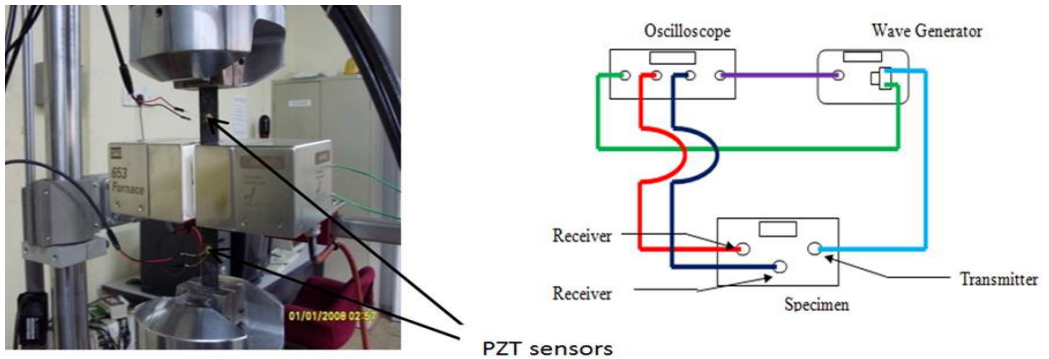
Fig. 4. Test specimen with the addition of PZT transducers

The PZT sensors were bonded by polyester/acrylic tape to the specimens which were connected to the Textronix machine wave generator at an output frequency of 250 kHz with 5 burst at 33 kHz. Fig. 4 shows the connection of the equipment.

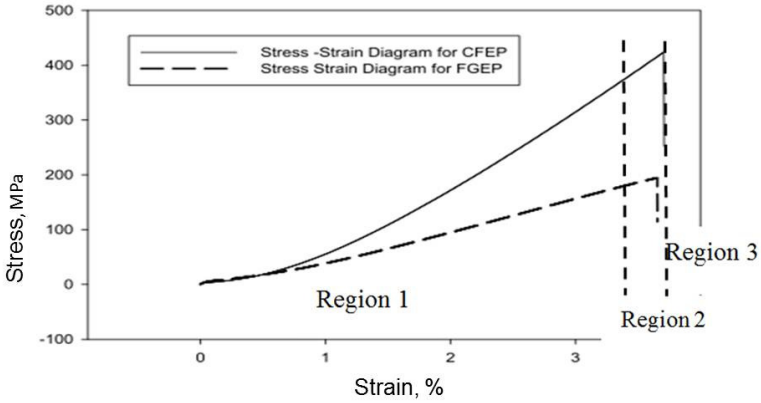
Fig. 5. Stress-strain diagram for FGEP and CFEP without thermal stress

Stress-strain diagram for both FGEP and CFEP revealed the behavior of brittle materials under tensile load. A sudden drop at the end of the elastic curves depicted the total failure of the both FGEP and CFEP composite materials as shown in Fig. 5. The graph was segregated into three regions. Region 1 lies within the elastic region. Region 2 is just before reaching the ultimate stress and Region 3 is right after the breaking takes place. Fig. 5 indicates that there is a significant strength difference between the FGEP and CFEP. The strength of CFEP is twice as the FGEP panels.

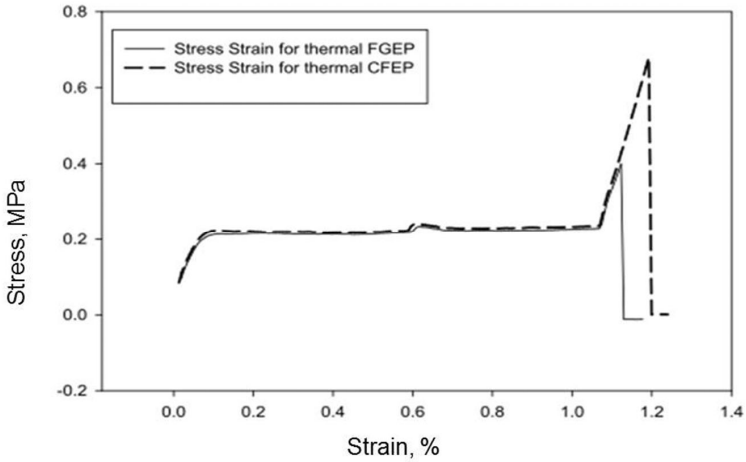
Fig. 6. Stress strain diagram for FGEP and CFEP with thermal stress

However, the application of heat revealed a different behavior on the stress-strain diagram whereby there was no change in stress although the strain was increased such as shown in Fig. 6. Meanwhile, the effects of thermal condition prove a significant reduction in terms of strengths. The main reason is due to the use of low temperature (LT) epoxy resin. The typical LT resin cannot withstand high temperature due to the weak bonding of the resin molecules. The resin lost its integrity and breaks when the load is applied. Therefore the fibers solely carry the main stress until the structure fails.

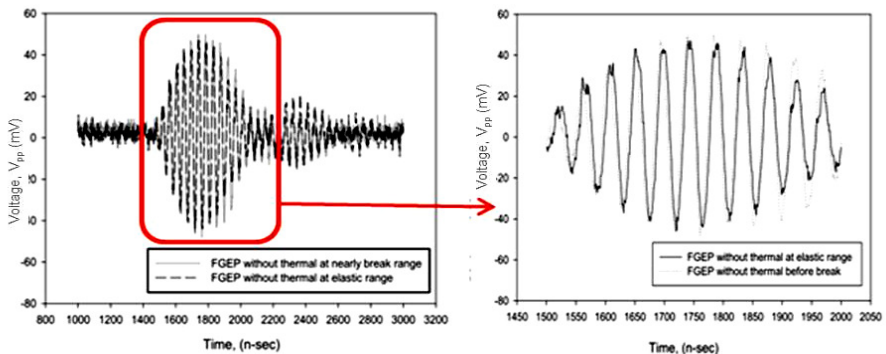
Fig. 12. FGEP comparison without thermal stress

Further investigations were carried out in order to acquire more information on the signal transmission at the linear range of the stress-strain diagram and momentarily before the specimens break. Before the specimens break a low clicking sound was heard due to the fracture of individual fibers before the total rupture occurred. At this point the specimens lose their structural integrity and the behavior of the lamb wave revealed anomalies from the pristine condition. The conditions were compared for each individual specimen as shown in Figs. 12-15.

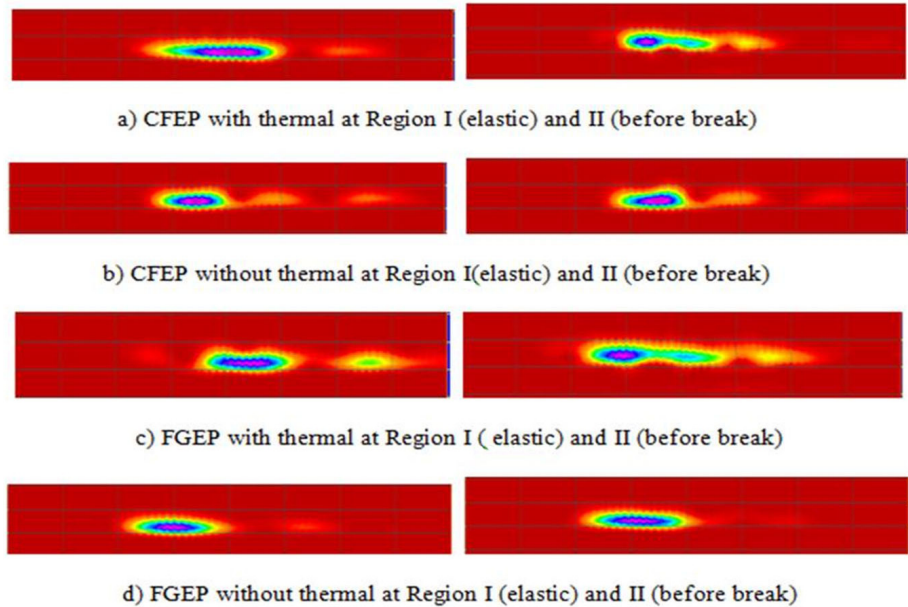
Fig. 16. Conditions with and without thermal influence

Wavelet analyses for both CFEP and FGEP with and without thermal influence are shown in Fig. 16. The signals are processed by using Autosignal employing Wavelet Filtering and

Construction function. The wavelet shows the frequency intensity of the receiving PZT sensors. Each of the wavelet intensity indicates a significant echo produced at the trailing of the signals. Since there is only a single attenuation during the interrogation process, the effect of thermal stresses produces significant trailing echo in which might have produced by the irregularities due to the heat applied. However at this stage, it is unknown to predict the strength and severity of the surface deterioration as it requires further investigation occurring at both Region 1 and II.

Thermal effect distinctly demonstrates the wavelet of the PZT sensors being distorted. This appeared due to the change of the grain/molecular structure altered by the heat. At Region 1, the wavelet reveals a similar pattern in which the low frequency and high frequency wavelet exist within the signal spectrum. However, when the materials nearly reach the breaking point (Region 2), both low frequency and high frequency wavelet coalesce. At this stage it is believed that micro-cracking of either resin or fiber breakage was initiated.
