1491. Vibration as deciding parameter during revitalization process for replacing the bucket wheel drive

Abstract. After years of excavator's operation in adverse conditions, one can expect a ratio between the bucket wheel drive and bucket wheel boom which may lead to impairment of structural integrity. Finite elements method is defined as a diagnostic tool for the anomalies occurrence prevention during operation, and the measured acceleration as a proof of the model's correctness i.e. revitalization procedure. New solution of the bucket wheel drive reconstruction and revitalization (drive group replacing) is derived on the basis of detailed stress analysis, calculation results and measured accelerations at characteristic points. Operation life of the bucket wheel excavator is directly dependent of the steel structure durability. It is shown in practice that timely replacement of an old, irregular bucket wheel drive has a positive effect on the behavior of tubular structures of the bucket wheel boom. Experimental acceleration measurements must provide support to the numerical model based on finite elements method, which is main diagnostic tool.

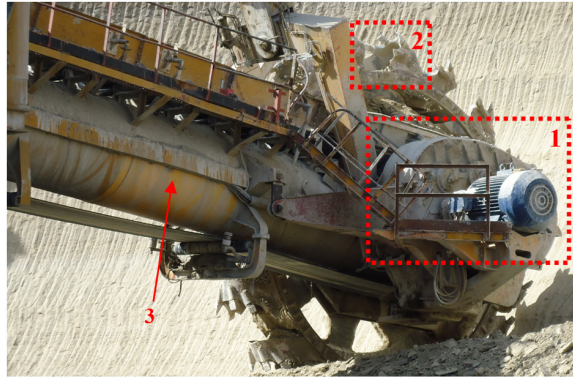
Fig. 1. Operating body of the bucket wheel excavator ER1250; 1 – bucket wheel drive, 2 – bucket with cutting elements, 3 – tubular structure of the bucket wheel boom

The aim was to reduce vibrations to an acceptable level and to increase the production capacity of the excavators, after some revitalization procedures. Expert analysis moved in two directions: the first – what is the impact of the excavator's bucket wheel drive on increased vibrations of bucket wheel boom structure, and the second – what is the impact of buckets and cutting elements on increased boom vibrations. Fig. 1 shows the layout of the bucket wheel excavator ER1250.

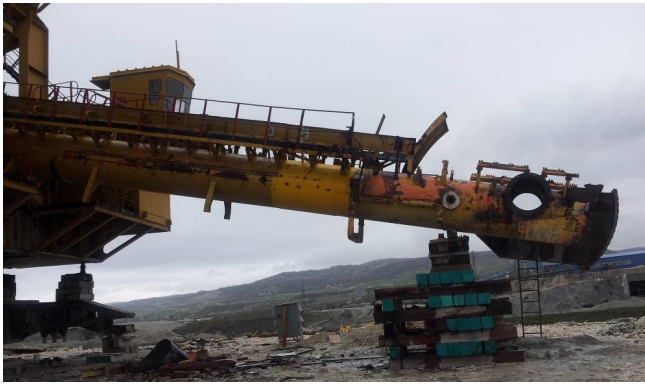
Fig. 2. BWE ER1250 bucket wheel boom with dismantled drive and bucket wheel

Structure strength diagnostics involves the analysis of the condition, behavior and structural deterioration as well as the assessment of the residual strength, operating life, mode of operation and revitalization extent. Analysis of the boom tubular structure means computer calculation using the finite elements method (FEM) and as mandatory, it requires experimental measurements. This allows determination of the actual structure behavior, a reliable forecast of its response in mining, obtaining choice and decision parameters, determination of reasons for bad or loosening behavior, assessment of exploitation lifetime and reliable operation lifetime. Fig. 2 provides the appearance of the bucket wheel ER1250 boom (dismantled elements of the drive and bucket wheel – with only a steel structure that is left).

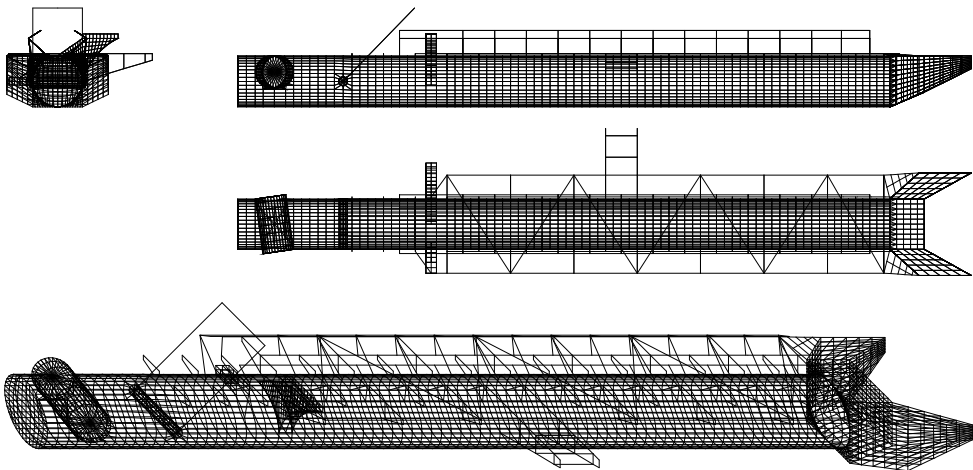
Model of tubular structure was made by using finite elements method. 5245 nodal points is defined in total, 703 linear finite elements and 5161 surface finite elements. Boom model is shown in Fig. 3.

Fig. 3. Bucket wheel boom model

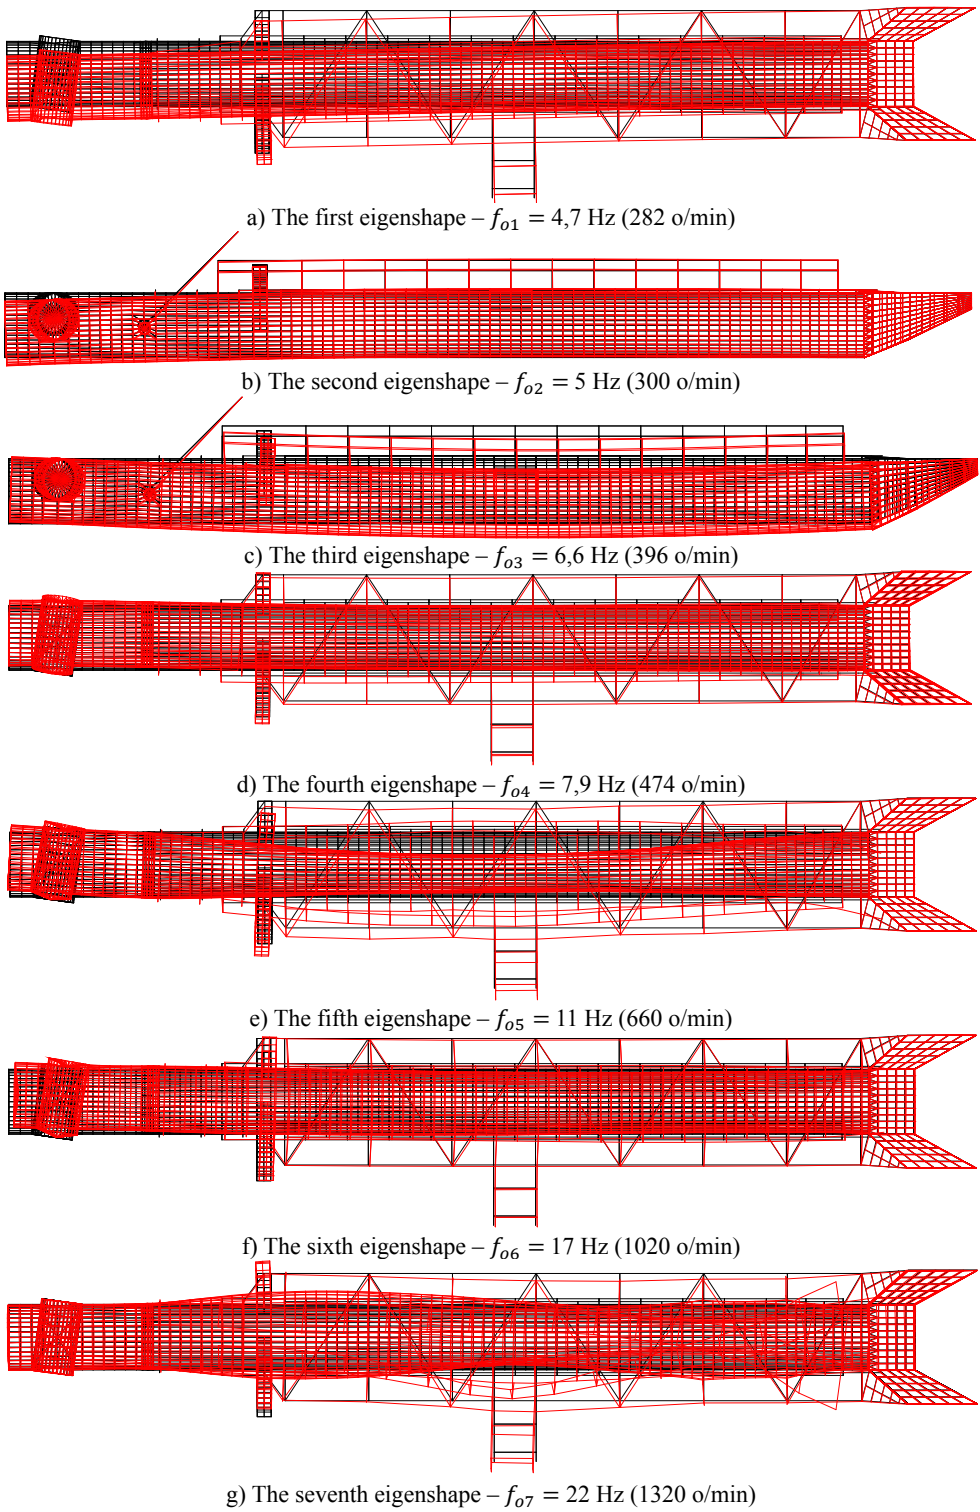
Fig. 4 provides a dynamic calculation of own frequencies and vibration (the first seven eigenshape).

Fig. 4. The first seven eigenshape forms

Note that dominant frequencies of boom structure vibration are located at 5, 7, 8, 11, 17 and

22 Hz. Since excavator has the ability to perform digging with different speeds (introduced is frequency regulation) after revitalization, speeds that excess nominal (1000 min^{-1}) and speeds at the level less than 70 % of the nominal speed (700 min^{-1}) should be avoided. In other words, it means that digging process is in the range from 11 to 17 Hz, to avoid overlapping between the dominant structure frequencies and excitation frequencies (in this case from the bucket wheel drive).

Such negative behavior comes mainly from suspension of the bucket wheel drive torque rod on the boom (in other words, from the drive itself), but also out from the cutting elements on buckets. Overlapping of the second, third and fourth form of the numerical model oscillation ($f_{o2} = 5 \text{ Hz} = 300 \text{ min}^{-1}$, $f_{o3} = 6.6 \text{ Hz} = 396 \text{ min}^{-1}$, $f_{o4} = 7.9 \text{ Hz} = 474 \text{ min}^{-1}$, Fig. 4), with the measured dominant drive group and boom frequencies should be specially emphasized (Fig. 6). The strong influence of excitation, both from the entry process and exit process of buckets from the digging process, and the elements of bucket wheel drive on diagrams in time domain (Fig. 6) is being noticed. For this type of vibration it can be said that it corresponds to excitation rotation frequencies of the bucket wheel gear elements.

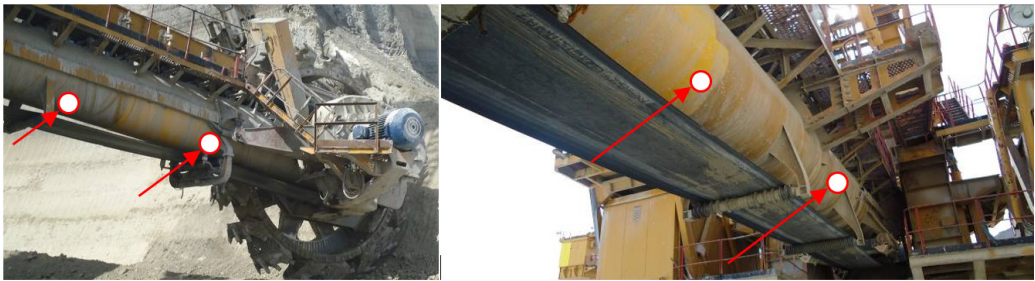
Measurements were carried out at the bucket wheel boom – the boom tube, i.e. on the 4 measuring points along the boom (Fig. 5). Fig. 6 shows the measuring results of the acceleration in the time and frequency domain on these measuring points. Applied color lines represent the following measuring directions: black line – transverse horizontal direction to the operating boom, red line – direction along the operating boom and a blue line – vertical direction.

Fig. 5. Location of the acceleration measurement points on the boom

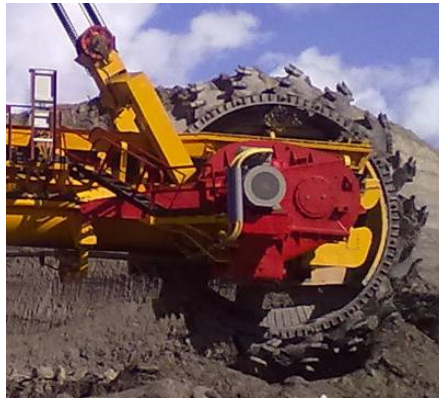
Revitalization of the excavator and replacement of the bucket wheel drive was done in the beginning of year 2013. New, modernized bucket wheel drive is shown in Fig. 7.

Fig. 7. New drive of the bucket wheel excavator ER1250 operating body

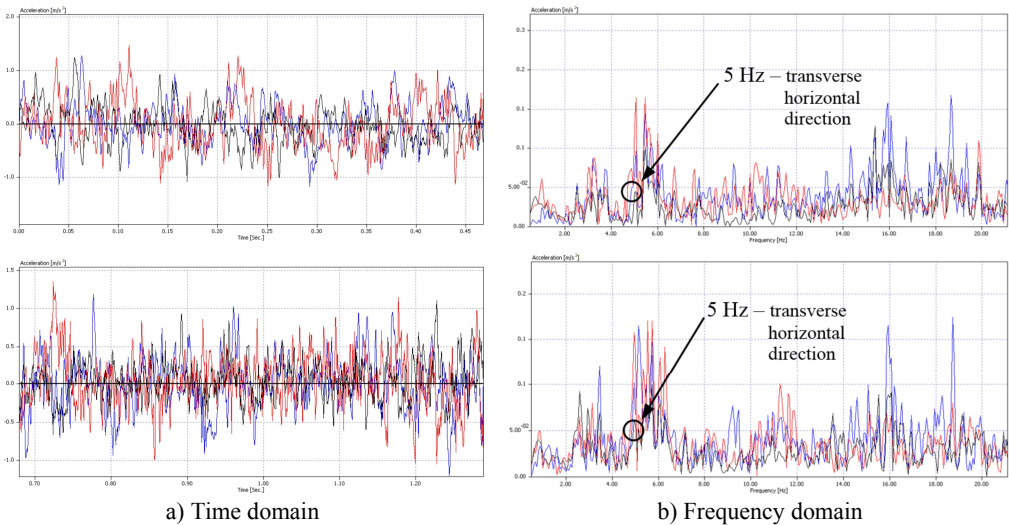
Measurements after the performed revitalization were carried out during March 2013. Measurements were performed in the same points as during the measurements before revitalization of the drive group. During the measurement the same apparatus was used for the measurement. Fig. 8 shows acceleration results in the time and frequent domain after replacement.

- Lower but still high acceleration values in the range up to 1 G were recorded,
- Dominant frequencies of the drive group and boom are still about 5, 6 and 10 Hz (300, 360 and 600 min⁻¹), but with a much lower amplitudes (maximum values were in the range up to about 0.1-0.15 m/s²);
- By the introduction of a new drive, a lot higher degree of the whole system rigidity was achieved (from the drive suspension for the boom, up to a new performance of the gearbox with

– The value of measured amplitudes on the characteristic measuring points is for 10-15 times less than with the old performance of the bucket wheel drive (gearbox).

Fig. 8. Typical vibration diagrams after revitalization (time and frequency domain)

Previous measurements on the bucket wheel boom indicates favorable dynamic behavior, which is reflected in the following:

Measured accelerations confirmed the correctness of the bucket wheel drive replacement, i.e. measured vibrations provided numerical model confirmation, its validity and executed revitalization procedure. New drive group has raised the level of rigidness (especially in terms of reducing clearance and vibration damping), with better suspension of the bucket wheel boom structure, where it had a positive effect on the behavior of the boom supporting steel structure.
