1501. Shaking table test for a scale-down reinforced concrete structure considering corrosive deterioration

Abstract. The degradation of concrete and rebar corrosion are considered a key factor in the durability of reinforced concrete structures and a major concern for civil engineers over the past few years. This study is focus on the variation of natural frequency, dynamic properties and seismic spectral in a deteriorated scale-down reinforced concrete frame specimen with rebar corrosion. The dynamic properties were experimentally studied though shaking table tests and the corrosive behaviors were experimentally studied though accelerated corrosion test. Test results presented that the corroded reinforced concrete specimens presented the changes in the dynamic response especially natural frequencies and response spectrum and rebar corrosion caused significant charges in dynamic responses. In conclusion, the deteriorated scale-down reinforced concrete test is useful for structural assessments and appraisals applied to full-scale structures.

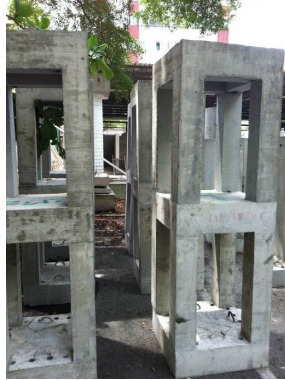
Fig. 1. Appearance of the RC frame specimens

The scale-down RC frame specimen is 2-stories and structure and the dimension of typical specimen is 220 cm high, 70 cm wide, 70 cm deep and the net weigh is approximately 950 kgf. In addition, the self-consolidating concrete of 450 kg/cm² was used in accordance with ASTM C1611 and the embedded #3 rebar was made of medium carbon steel following the specification of ASTM A615. The appearance and details of RC frame specimen are shown in Figs. 1 to 2, respectively.

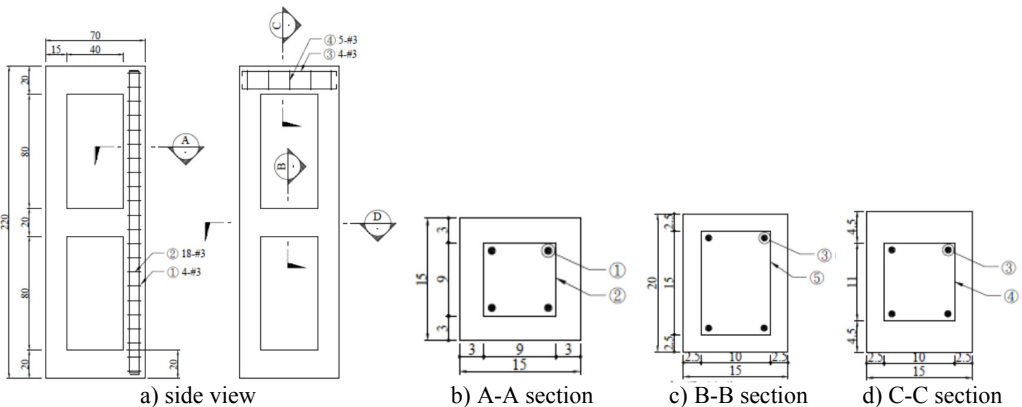
Fig. 2. Drawing of the RC specimens

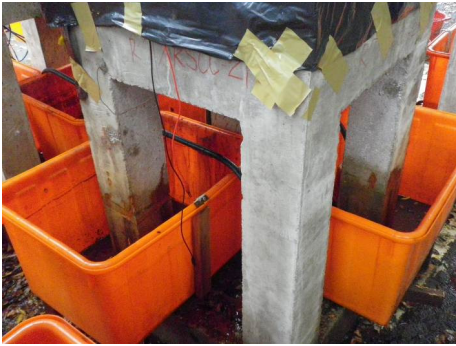
Fig. 3. Appearance of the corrosion test set-up

where F is Faraday's constant (96500 coulombs/equivalent), n is the number of equivalent exchange, and a is the atomic weight. The appearance of the corrosion test set-up is shown in Fig. 3.

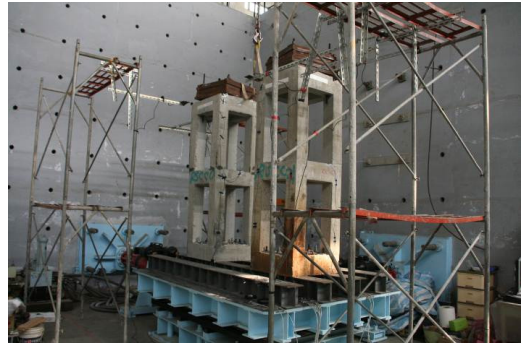
Fig. 4. Appearance of the shaking table test set-up

The RC frame specimens were connected to the shaking table by bolts and the appearance of the shaking table test is shown in Fig. 4. The shaking table has 2 degree of freedom system with a frequency range between 0.1-50 Hz and the maximum specimen weight is 6 tons. In addition, the maximum acceleration for lateral and longitudinal is 0.9 g and 1.0 g, respectively. The testing cases of uni-axial white noise wave testing and a set of tri-axial artificial motion testing and impact pulse testing were implemented for each testing item. The testing programs and associated input motion were scheduled as shown in Table 1 and the acceleration time histories of fictitious seismic input motion in N-S and E-W direction are shown in Fig. 5.

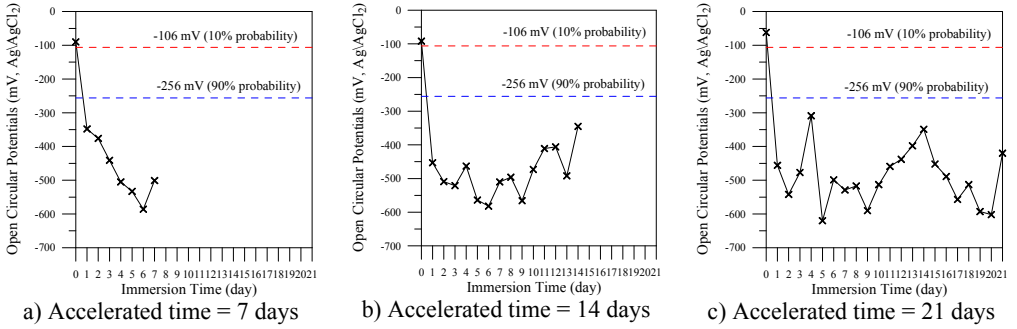
Fig. 6. Open circular potentials versus immersion time curves

probability here is less than 10 % that reinforcing may corrode. When the potential ranges from -106 mV to -256 mV (Ag/AgCl_2), corrosion probability is uncertain and corrosion probability may be higher than 90 % for OCPs higher than -256 mV (Ag/AgCl_2). The relationships between immersion times and potentials at the accelerated time of 7, 14 and 21 days are illustrated in Figs. 6(a) to 6(c), respectively. After the immersion time of 1 day, the OCP values of all specimens dropped rapidly over -256 mV and hightend the corrosion probability of reinforcing steel. The OCP curves of the specimens at the immersion time of 7 days dropped rapidly from -350 mV to -600 mV and cracks on the surface of the concrete can be found.

The curves at 14 days also dropped rapidly up to -600 mV and the potentials rose slightly up to -400 mV due to the passive film broken. The potentials of the specimens for 21-days accelerated immersion *c* rapidly to -600 mV for immersion time from 2 to 9 days and rose to -450 mV from 10 to 16 days. And then the potentials dropped again up to -600 mV and the specimens had an active effect on accelerated progression toward active potentials. The significant cracks, rust and rusty spots were observed on the surface of the RC specimens as shown in Fig. 7.

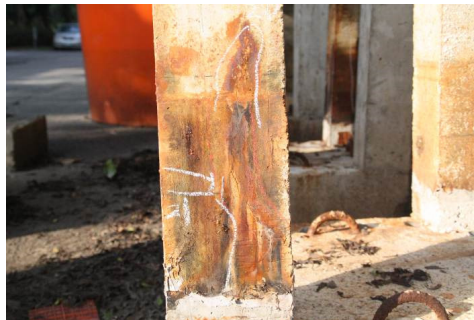
Fig. 7. Appearance of the cracks, rust and rusty spots on the surface of the specimens

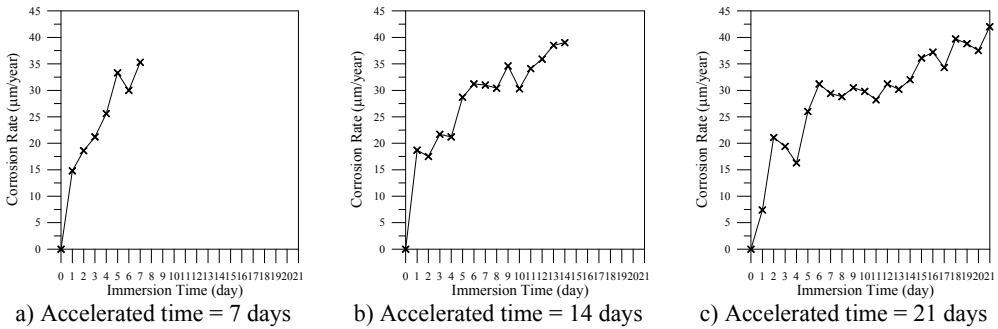
Fig. 8. Corrosion rate versus immersion time curves

The relationships between corrosion rate and immersion time at the accelerated time of 7, 14 and 21 days are shown in Figs. 8(a) to 8(c), respectively. The corrosion rate increased significantly with an increase in accelerated immersion time and reached steady value up to 32, 38 and 40 $\mu\text{m}/\text{year}$ of the specimens at the accelerated time of 7, 14 and 21 days, respectively. It also indicated that the RC specimen was like to be a high corrosion rate [10] in this accelerated method. The amount of chloride ions had reached to the critical value. This means that the passive protective film on the rebar had been totally spoiled, and thus the corrosion rate of the rebar increased abruptly. Therefore, the accelerated corrosion method is suitable for carrying out the corrosion evaluation of the scale-down RC frame specimen. In addition, the 2D plot of corrosion rate value is shown in Fig. 9. The corrosion rate of the RC specimen increases with the height

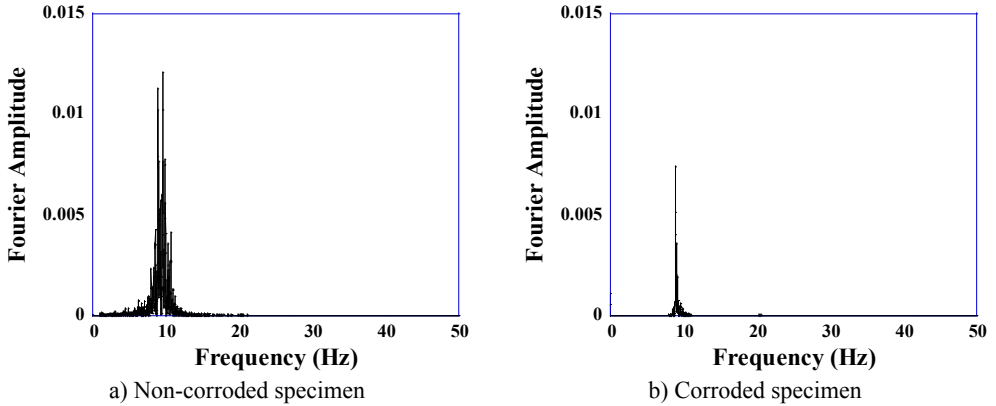
Fig. 10. Fourier amplitude versus frequency curves

The natural frequencies generated by white noise method using shaking table test and transfer function curves before and after 21 day accelerated immersion are shown in Fig. 10(a) and 10(b), respectively. The natural frequency of 1st mode in non-corroded and corroded specimen was 9.62 and 8.89 Hz. It was also observed in general the trend of the magnitude of the percentage change in natural frequencies decreased with the corrosion rate increased. The movements of aggressive ions toward the surface of embedded reinforcing steels caused the serious corroded rebar debonding and loss in structural stiffness. Further, the rebar corrosion of the RC frame specimen caused slight deteriorated to the natural frequencies and structural capacity.

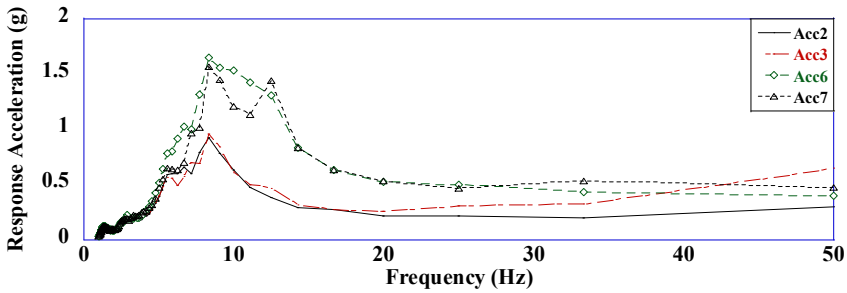
Fig. 13. Response acceleration versus frequency curves ($a = 0.20$ g)

The response spectral curves (damping ratio = 5 %) of the non-corroded and corroded specimens at the peak ground acceleration of 0.20, 0.40 and 0.60 g for two direction test are illustrated in Figs. 13 to 15, respectively. In those figures, Acc2 and Acc6 represents the middle and top accelerometers of the non-corroded specimen, respectively; Acc3 and Acc7 represents the middle and top accelerometers of the corroded specimen, respectively. It indicated that the peak of middle floor tended towards lower frequency domain than that of top floor. The peak of spectral response curves in the corroded specimens tended towards larger response acceleration than those in the non-corroded specimens and it was especially significant to the specimens at the peak ground acceleration of 0.60 g. Therefore, the corroded RC frame specimens had larger dynamic response and were consistency with the results of displacement, acceleration measurement and corrosion test.

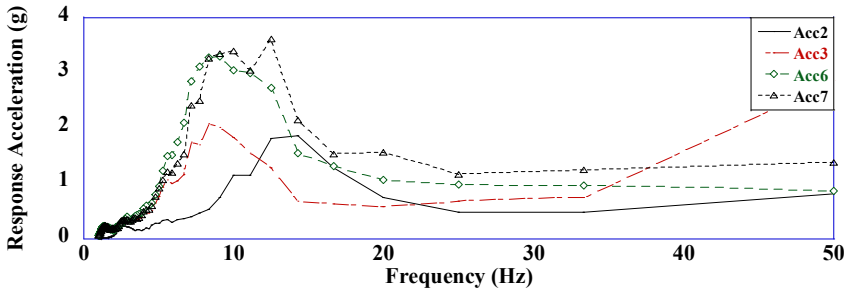
Fig. 14. Response acceleration versus frequency curves ($a = 0.40$ g)

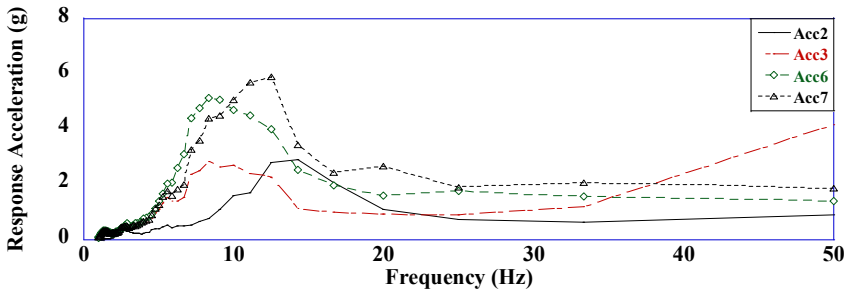
Fig. 15. Response acceleration versus frequency curves ($a = 0.60$ g)
