2218. Seismic performance evaluation and improvement for damaged reinforcement concrete piers using a fiber steel composite plate

Abstract. The seismic performance evaluation and retrofit process are very important in damaged bridges. If the result is not appropriate, then retrofit process are required. In this paper, to validate the seismic performance of retrofitted bridge experimentally, an experimental study was conducted to verify the application and efficiency of the jacket retrofit method to ensure seismic performance of damaged reinforcement concrete (RC) bridge piers. A total of 4 RC bridge piers was made and then 3 piers were pre-loaded under the range of service load to be damaged. These piers were retrofitted and repaired using a carbon fiber reinforced polymer (CFRP), steel plate, and fiber steel composite (FSC) plates. These retrofitted and repaired piers were subjected to monotonic loading. Hysteresis and ultimate behaviors of the 3 RC piers were evaluated and compared with those of 1 non-damaged pier (standard specimen). As a test result, the retrofitted and repaired RC bridge piers applied by the jacket retrofit method were ensured under the targeted displacement

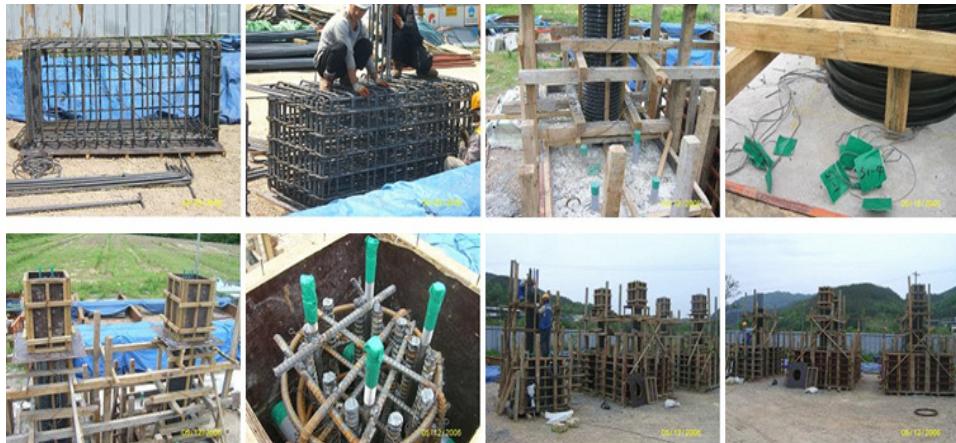
Fig. 2. The making of specimens

In order to compare performance between standard specimen and retrofit specimens, the detail arrangement of reinforcement and section of the specimens were made identically. Though specimens were circular in cross section, foundation and coping of the specimens had different cross sections because the foundation should have greater stiffness than the pier to be fully fixed and the section of the coping should be determined by considering shape and size of the actuator. The 28 days concrete compressive strength (f_{28}) was in the 24 MPa. Pouring the concrete into the specimens was done at the foundation first and then done at the pier. Strain gauges were attached to the main and stirrup reinforcement to measure the strain of reinforcement before pouring concrete. Main reinforcement was D_{22} (Diameter of 22 mm), hoop reinforcement and cross-tie were D_{13} (Diameter of 13 mm). As using that reinforcement, the problems about geometric and material similarities that might arise because of a small-scale model was excluded as much as possible. The material properties of the specimen are provided in Table 1. The cross section of specimen is shown in Fig. 1 and the making of the specimens are shown in Fig. 2.

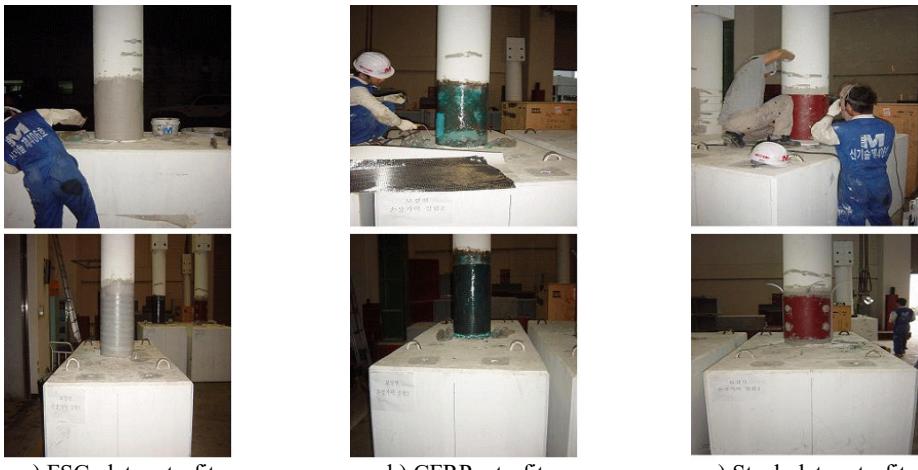
a) FSC plate retrofit

b) CFRP retrofit

c) Steel plate retrofit

Fig. 6. Repair and retrofit of the damaged specimen by pre-loading

The amount of retrofit for each method was determined to make the same strength. The material properties of CFRP, steel plate and FSC plate are provided in Table 2. And the mechanical behavior of CFRP, steel plate and FSC plate are provided Fig. 5. The process of repair and retrofit is shown in Fig. 6.

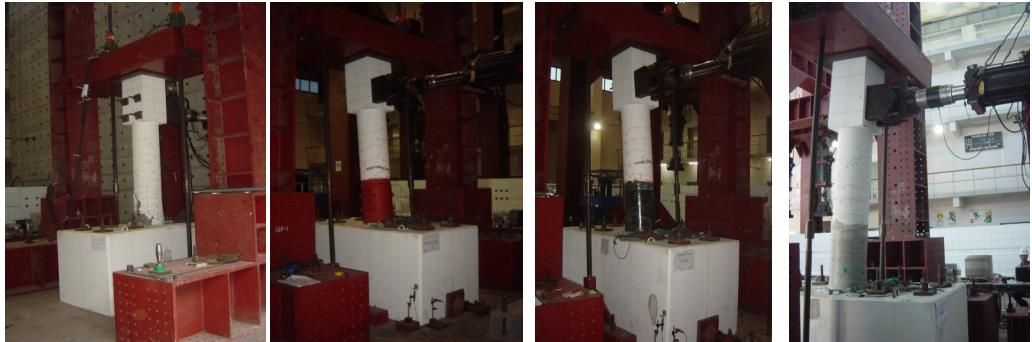
Fig. 7. Testing photo of the specimens

As a test result, an initial crack of the standard specimen occurred horizontally at the interface between a foundation and a pier. And as the load was gradually increased, the horizontal and vertical cracks were occurred at the middle of pier. Finally, as typical flexural failure such as a separation of the concrete cover and crushing was shown, load-carrying capacity was drastically reduced. In case of repaired and retrofitted specimens, the initial cracks occurred horizontally above the boundary of the retrofit plates. As the load was gradually increased, the horizontal and vertical cracks were occurred at the middle of the piers. However, the numbers of vertical cracks were significantly less than those of the standard specimen due to the retrofit effect. As the load was increased, the reinforcement was yielded and showed ductility and then failures were finally shown as a debonding of the retrofit plates. The results of testing, failure and load-displacement curves for each specimen are shown in Figs. 7-9.

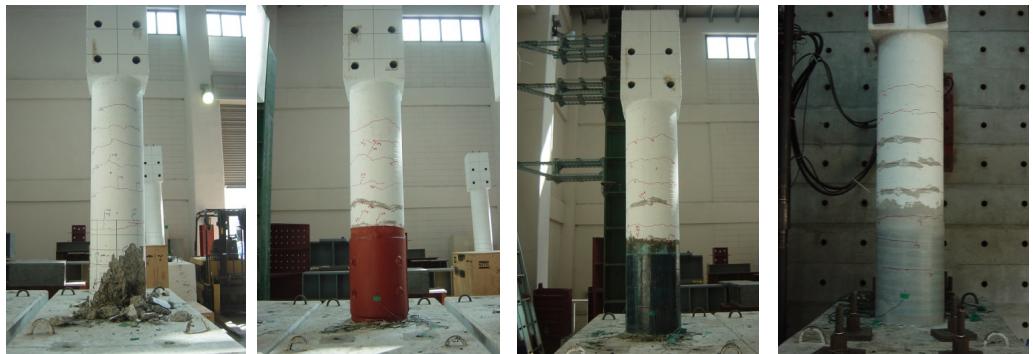
a) Standard specimen b) Retrofit specimen with steel plate c) Retrofit specimen with FSC plate d) Retrofit specimen with CFRP

Fig. 8. Failure photo of the specimens
