2213. Improvement of the durability of rolling bearings in high-speed drive systems

Abstract. At present, in many high-speed machines (e.g. appliances) bearing systems based on ball bearings. These solutions are used because of the low cost of production. However, in the process of operation, it appears that the use of this type of bearings has low durability of the system associated with its underload. In these systems, the output shaft rotates at a very high speed (20 thousand RPM), so even slight imbalance causes very high inertia forces aggravating bearings with dynamic reactions. These reactions rotate with the shaft, and their rotation frequency is equal to the frequency of the shaft rotation. Clearances in the bearing lead to the situation where the shaft together with the inner ring vibrates. These vibrations cause the slip between the balls and the cage of the bearing. As a result, the cage is a subject to accelerated damage because of sliding and collisions with the balls. Another factor affecting the durability of the bearing system is work at temperatures exceeding permissible limits. The article compares two design solutions and their impact on the life of the bearing

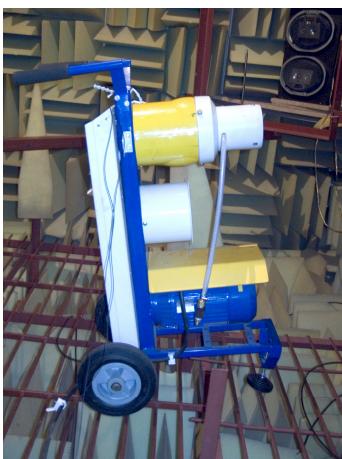
Fig. 1. Industrial air freshener

The device used for refreshing the air in industrial halls was used for the research. In this position (Fig. 1) ball bearings 6001-2Z (2Z indicates double-sided sealed bearings) with standard quality were used in the bearing system. Experiment was conducted in anechoic chamber due to very high level of generated noise (in order to attach accelerometers directly over the bearings we had to remove the soundproof covers).

The measurements were carried out at the bench shown in Figure 1 in an anechoic chamber with the use of miniature accelerometers B & K 4500 B & K and 4501 mounted directly on the bearing node. Measurements were performed in two directions: radial and axial on the bearing housing on the fan side. Recordings of vibroacoustic signal were made by the RoadRunner's LMS analyzer. Further analysis of the recorded signal was carried out in MATLAB®.

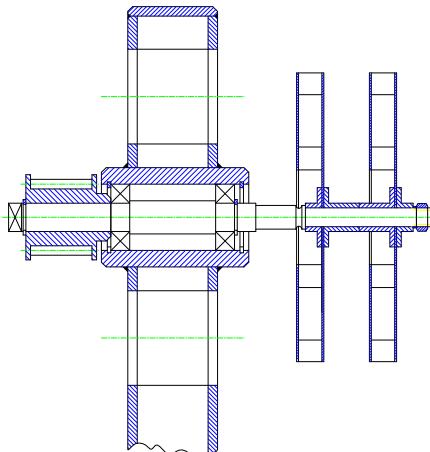
In constructional solution (Fig. 2) there were used two bearings mounted rigidly on the shaft. The location in the housing is a floating type and allows to move the system of rotor axially by about 1mm. At the free end of the shaft, doubled fan pushing the air through system of the nozzles. At the other end of the shaft, the pulley driven by the belt is placed. During the device operation by the user, it turned out that the bearing on the fan side is worn faster (i.e. after 50-60 hours) and, in extreme cases the cage is completely damaged, which leads to the damage of the rotor shaft. After checking the loads, there appeared some assumptions that low durability may be caused by the underload of the system. This situation results in a low axial stiffness and thus in increased level of vibrations in the bearing nodes, which in turn entails accelerated wear of the rolling elements and the failure of the drive system.

Fig. 2. Diagram of bearing of the examined object

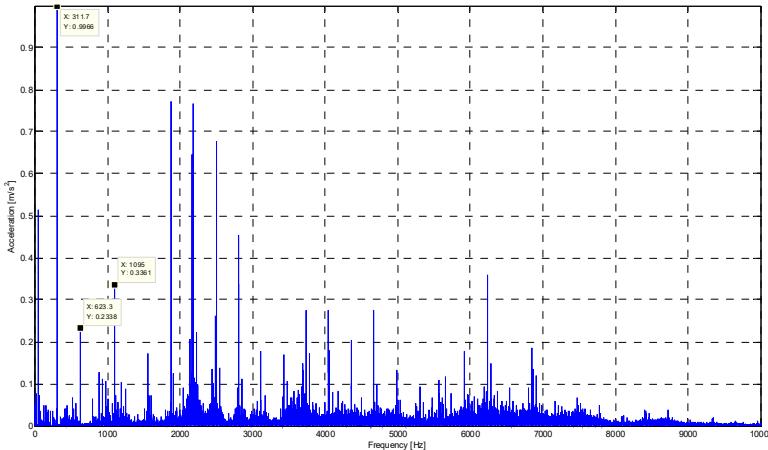
Fig. 3. Example spectrum of vibrations – the lateral direction

Figs. 3-4 show exemplary spectra of vibration in lateral and axial directions. After preliminary analysis it was possible to observe that the propagation of vibration energy is significantly higher in axial direction. There was clearly highlighted the impact of the solution on the level of vibrations generated in the system and the dominant influence of errors of making and installing the bearings and rotor unbalance on the spectrum of generated frequencies [4]. In addition, the supposition of the existence of bearings underload in the tested device was confirmed. The experiment was made for bearings “brand new” without their prior running in.

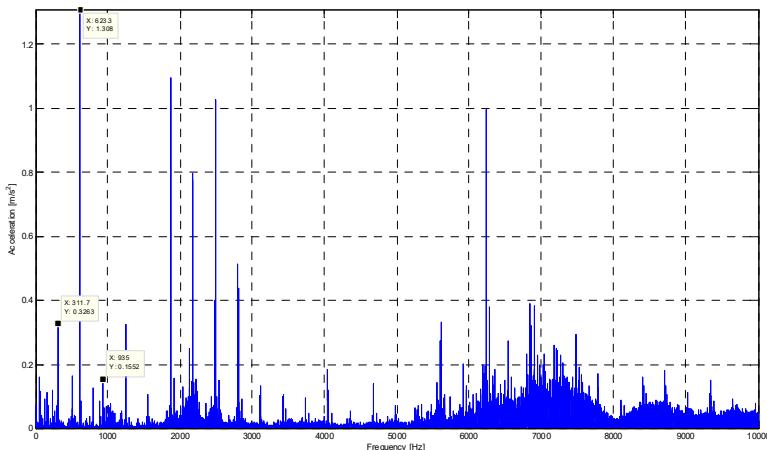
Fig. 4. Example spectrum of vibrations – axial direction

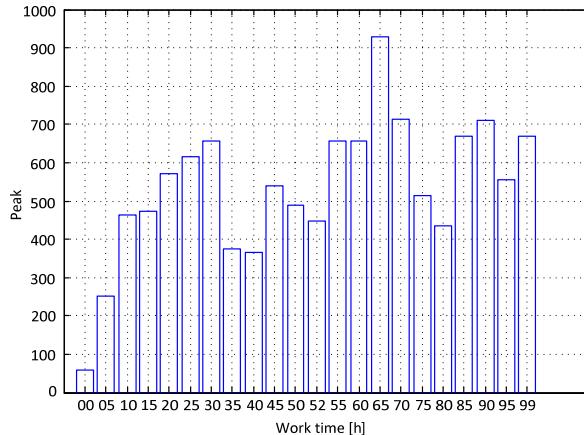
Fig. 5. Example of peak indicator – lateral vibrations

Example values of Peak, RMS, XSK and Rice_a indicators are shown in Figs. 5-10.

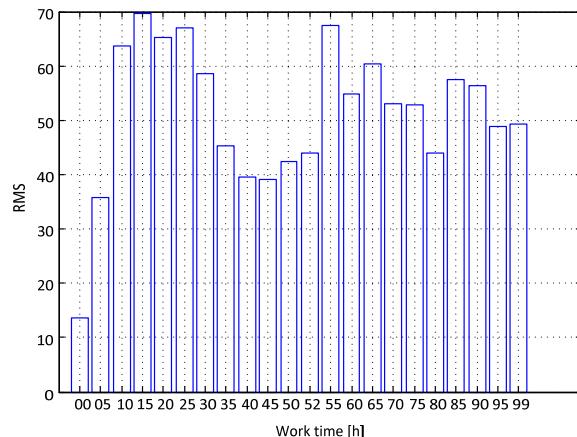
Fig. 6. Example of RMS indicator – lateral vibrations

- Only the analysis of RMS indicator gave interpretable results, so I use it for further analysis and on its basis the following conclusions were drawn:

- Damage to the bearing is visible after 15 hours of operation,
 - To achieve the 30 hours of work there can be seen an increase in vibration level with the evolution of damage. However, after that time the vibration level begins to decline, so we can suppose that the bearing is running in.

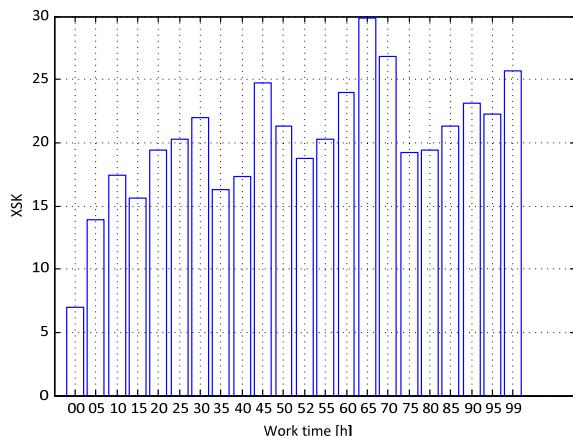
Fig. 7. Example of XSK indicator – lateral vibrations

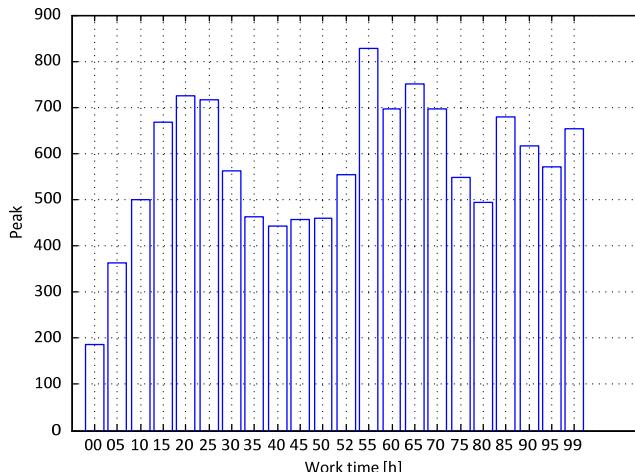
Fig. 8. Example of peak indicator – axial vibrations

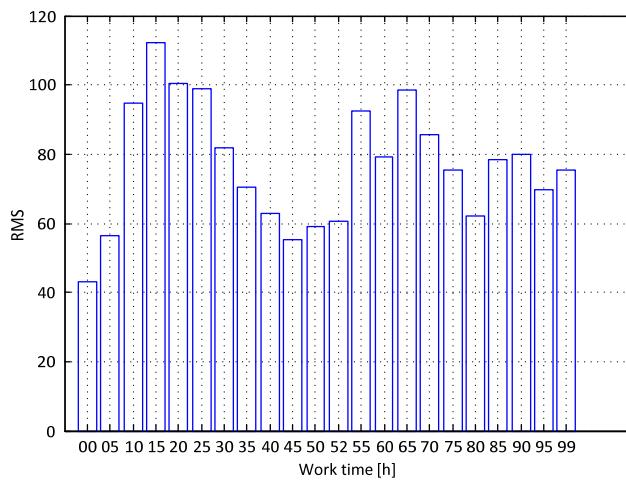
Fig. 9. Example of RMS indicator – axial vibrations

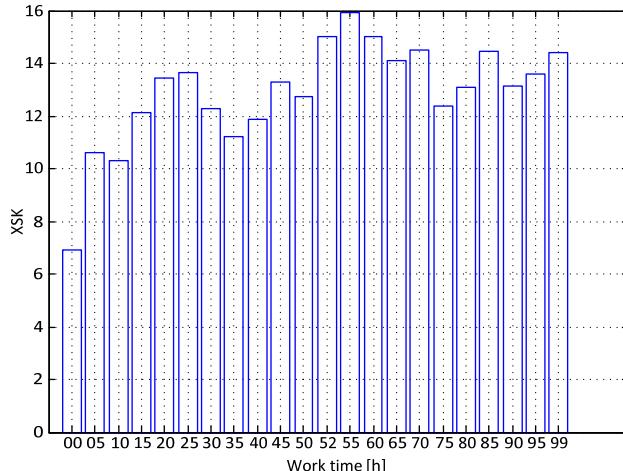
Fig. 10. Example of XSK indicator – axial vibrations

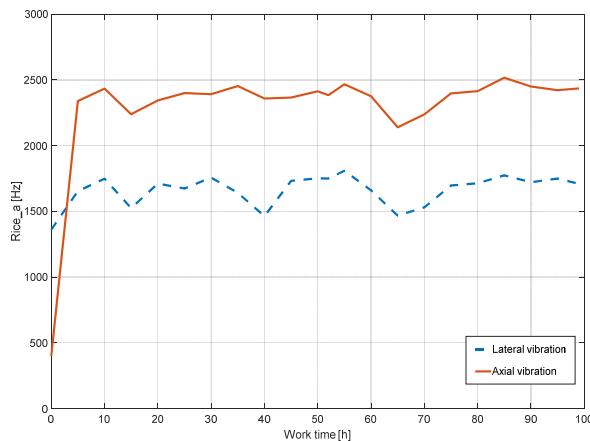
Fig. 11. Example of XSK indicator

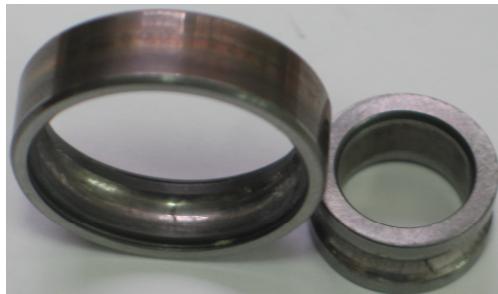
After stopping the experiment at 99 hours of work and disassembly of the test station, the bearings were analyzed. It shows that the bearing on the fun side has a highly damaged cage and is almost completely void of grease and its remains were solidified. As a result, after rapid increase of rolling resistance, the inner and outer ring and rolling elements (balls) were damaged. This is shown in Fig. 12 where the ring damage and the change of bearing color is clearly seen. It suggests work in conditions of severe overheating.

Fig. 12. Damage to the inner and outer ring

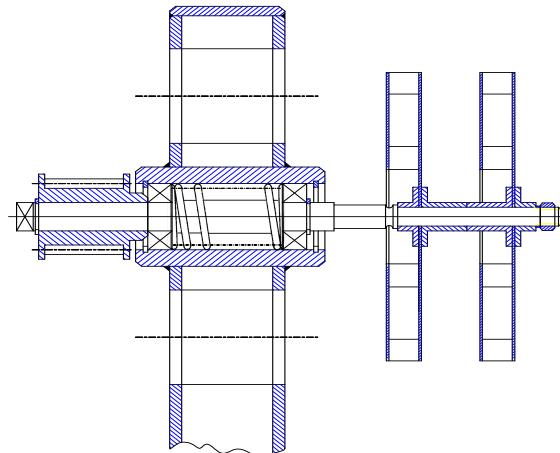
Basing on the results of the previous experiment, it was decided to repeat it for the same two bearings with an additional axial tension introduced with the use of a cylindrical spring with the pressing force 100 N. The scheme of this solution is shown in Fig. 13. The methodology of measurement was slightly changed. The record was done every hour so that it was possible to observe the early phase of damage.

Fig. 13. Bearing scheme with a spring 100 N

In the experiment conducted again there were changed the conditions of bearings lubrication by introducing the lubricant in the space between bearings and changing applied bearings into one

side sealed ones (6001-Z). This solution worked perfectly, despite the increased operating temperature in relation to the original solution, the device did not show any signs of damage to the bearings up to 230th hour when the experiment was stopped. After demounting the stand the bearings showed no visible signs of wear.

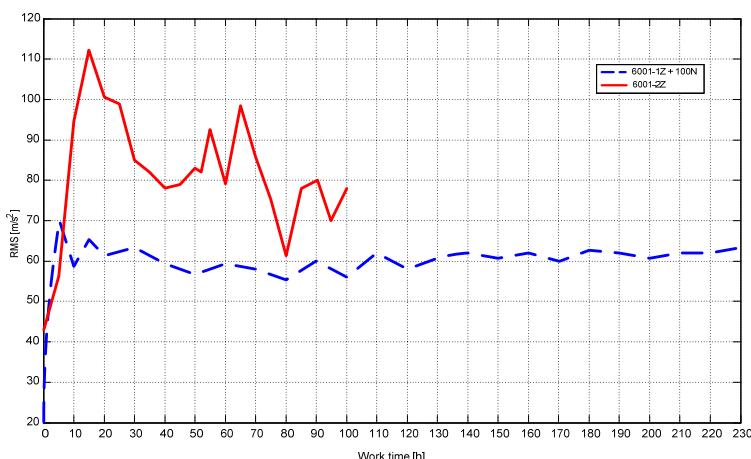
Comparison of the stability of both structures is shown in Fig. 14 on the example of the course of RMS ratio.

Fig. 14. Comparison of durability of applied constructional solutions.

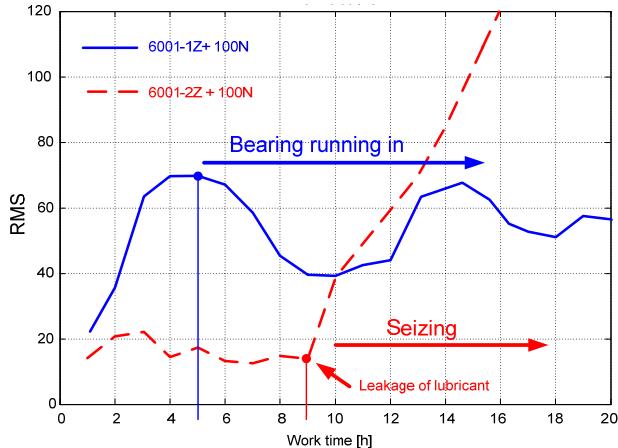
additional experiment for a changed constructional solution, with proper lubrication and without it. In the experiment, the emphasis was put on the first 20 hours of operation. The record of vibrational signal was performed every hour while performing a visual inspection of the system under study. The result of the experiment is shown in Fig. 15.

Fig. 15. The result of comparison of a 20-hour operation of examined solutions of lubrication

The example graph clearly shows an increase in the general level of vibrations in the system, which uses an additional amount of lubricant. However, despite the increase in the general level of bearing vibration, it works stable, does not overheat and undergo accelerated degradation. Solution with factory default lubrication works well, in a short time of operation, when the amount of squeezed grease from the bearing does not exceed approx. 90 % of its original volume. In the same period, the bearing with the excess of lubricant is a subject to the process of running in and the level of vibrations is reduced and stabilized. After 10 hours of work the seizing of the bearing without a proper lubrication causes (almost linear) rapid increase in the level of vibrations. The experiment was stopped before the assumed time (after 16 hours) to avoid seizing the bearing and destroying the station. Despite this, it occurred that the shaft journal where the bearing was placed was destroyed.
