2715. Remaining life assessment for boiler tubes affected by combined effect of wall thinning and overheating

Abstract. Boilers, the most troublesome components of electric power, chemical and processing plants generate high costs in unscheduled shutdowns, repairs and power replacement. Every occurrence of ruptured tubes leads to emergency shutdown of the entire plant. This paper describes the joint international effort to develop faster and more efficient methods for condition assessment and remaining life prediction for boiler tubes made of low-carbon steel. Authors have undertaken a systematic research with the major objective to correlate the results of combined nondestructive testing (NDT) with condition assessment of boiler tubes. The evaluation included non-contact wall thickness measurement with EMAT technology plus internal oxide layer measurement with specialized ultrasonics. While the first method shows the remaining tube wall thickness, thus allowing calculating total stress, the latter one has the potential to characterize microstructure degradation, which up to now could only be determined by destructive analysis. The special attention was directed towards identifica

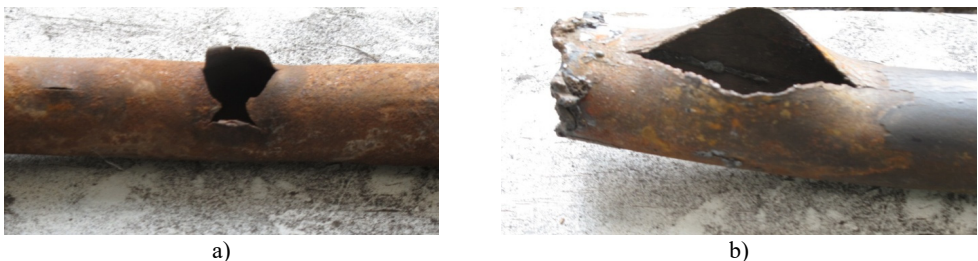
Fig. 1. Most common damage mechanisms observed in boiler water-wall with carbon steel material (Steel20): a) Surface corrosion and erosion causing wall thinning, b) thick-lip burst caused by long-term overheating and creep damage – note multiple longitudinal cracks in the vicinity of a burst

These initial investigations that included plant visits and literature search had concluded that in order for this research to be useful to plant operators in a specific geographical region of Central Asia, it has to concentrate on carbon steel as a material of choice for water-wall section of the boiler. At the same time, previous research results can be applied to reheater and superheater sections with Cr-Mo steel tubes. In summary, it was found that most common reasons for tube failures in Steel20 are: (i) external and internal corrosion and erosion, (ii) long-term overheating damage where the material strength gradually decreases with time, and (iii) short-term overheating, usually occurring during start-up or due to some unexpected occurrences, such as tube blockage, when tube temperature rises suddenly with consequent loss of tensile strength, so that hoop stress from internal pressure causes a violent rupture. It needs to mention at this point that both above types of failure are easy to recognize by a simple observation: while a long-term overheating causes a “thick-lip rupture” with many bulges and cracks visible around, a short-term overheating is connected with “thin-lip rupture” having sharp edges and usually no evidence of other damage around the burst [2]. Samples of actual tube failures are shown in Fig. 1.

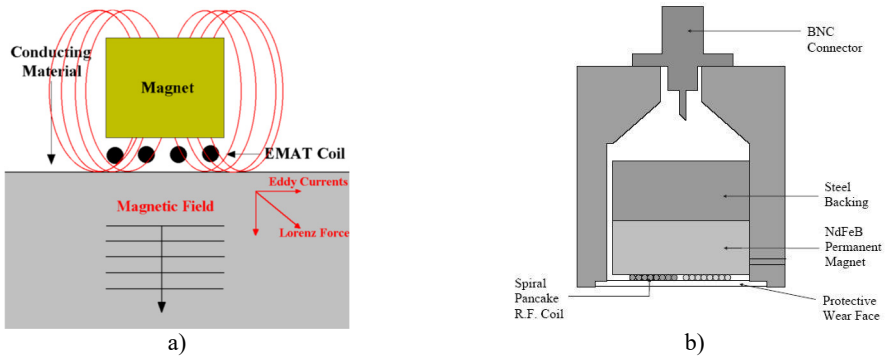
Fig. 2. a) Principle of EMAT operation and b) a typical design of EMAT transducer for thickness measurement

Technically, EMAT method relies on ultrasonic principle, however, while in standard UT system, ultrasonic wave is generated by a piezoelectric effect of a crystal transducer, EMAT generates such wave directly in tube material by electromagnetic method [8]. Fig. 2 shows the principle of operation and a typical design of EMAT transducers. The EMAT transducer has a strong permanent magnet, usually Neodymium-type and a spiral coil supplied with a current of high frequency (1-2 MHz). The current in the coil induces eddy currents on the surface of tested tube and the magnet “pushes” those currents into the tube in the form of elastic wave with

ultrasonic velocity, characteristic for a given metal. In the matter of fact, there are two ways that EMATs can generate elastic energy directly in the boiler water-wall. The first is via the “Lorentz force” mechanism where interaction between an applied magnetic field and induced eddy currents produces an elastic driving force. The second is through magnetostriction (MS), which is a magneto-elastic phenomenon where an alternating magnetic field generates an alternating elastic force, usually at the alternating field frequency. While the Lorentz force mechanism has been demonstrated to work well on boiler tubes, Lorentz force EMAT systems require much higher magnetization and are heavier and costlier than their magnetostrictive (MS) counterparts. The steel surface, especially for steels used for water-wall tubes has low magnetostrictive properties and for that reason, clean tubes cannot generate sufficient EMAT signal for useful inspection. However, when the metal is exposed to conditions commonly encountered in the fire box of coal-fired boilers (temperatures over 400-450 °C), a tightly bonded scale having a large MS coefficient is formed [9]. Elastic waves generated via this MS require very little excitation power and can result in very accurate thickness measurements.

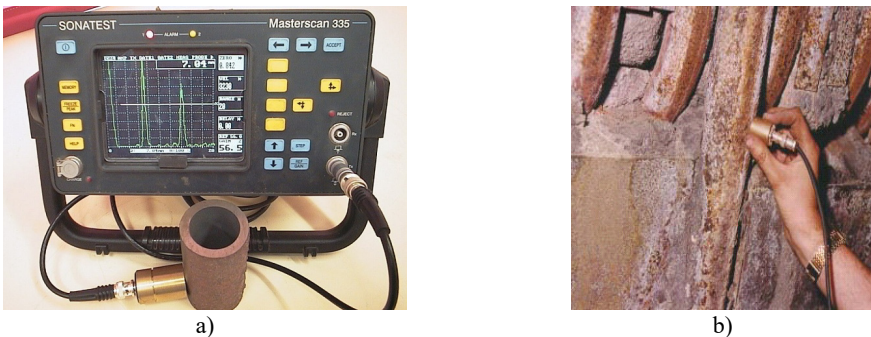
Fig. 3. a) EMAT transducer coupled with a popular standard UT instrument MS335 and b) the manual EMAT thickness measurement performed on boiler tubes

EMAT transducers can work with general-purpose ultrasonic instruments with certain modifications, most important being the adequate initial pulse, at least 400 V. Fig. 3 shows the EMAT transducer coupled with standard off-shelf UT equipment and how the manual inspection is done on boiler tubes.

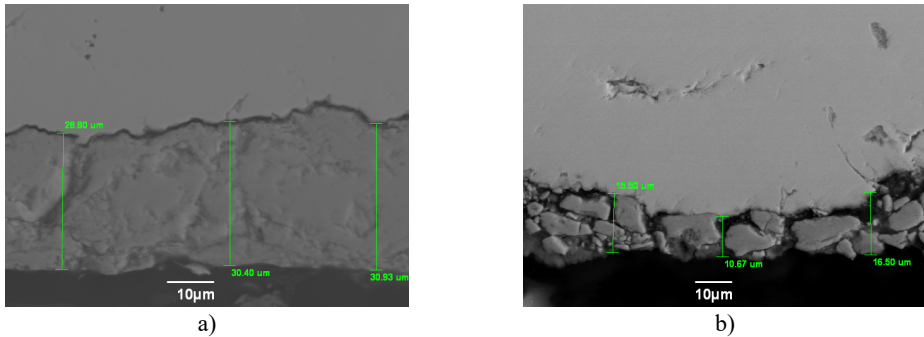
Sample No.	O (%)	Na	Al	Si	Cl	Fe
1	18.62	4.41	1.54	3.79	0.48	71.16
2	16.11	4.81	1.88	5.08	0.43	70.27

Fig. 4. Microphotographs of two (2) samples with external oxide scale of various thickness with their corresponding chemical analysis. A solid EMAT signal was obtained for the sample on the a) while the sample on the b) has produces only a sparse signal. This was most probably due to lack of adherence between the scale and parent metal in the b) sample [13]

Further phase analysis determined that the prevalent chemical compound in the scale was hematite (Fe_2O_3) with 65-70 % content with remaining compounds being iron silicate, iron manganese oxide and austenite. The presence of highly corrosive Cl was observed as well as Na, Al and Si which indicate that corrosion was caused by fusion of ash particles [11]. Neither chemical composition nor ferrous oxides contents differed from typical values obtained in other regions of the world. Also, EMAT signal characteristics and its variation in amplitude were both similar to usual results in USA and elsewhere. Occasional lack of coupling was most probably caused by non-adherence or loose adherence of the scale to tube material. This issue can be managed through proper design of the instrumentation, especially by increasing the strength of a magnet in EMAT transducer. Indeed, the research is now continuing with designing new transducers equipped with strongest Nd-Fe-B permanent magnets available on the market [12]. While existing transducers used magnets with energy of 32-35 MGsOe, the new series being

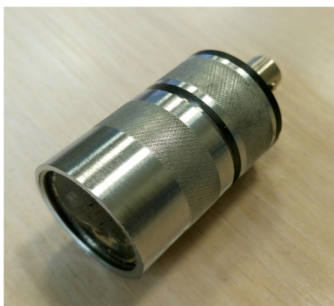
Fig. 5. Prototype of EMAT transducer designed for robotic crawler application

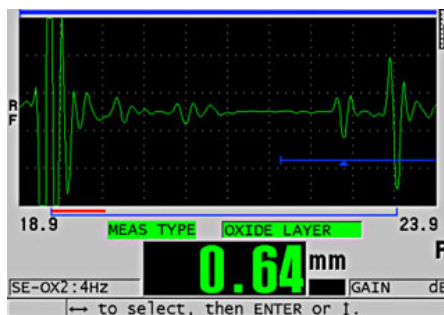
Fig. 7. Calibration reading from Olympus 38DL for internal oxide of known thickness (0.64 mm)

The industry experience had confirmed the importance of periodic internal scale thickness measurements as a tool for evaluating the useful operating life of boiler tubing. Over the past several years, many power plants throughout the world have indeed improved their ability to predict boiler tube failures, based, at least in part, upon an accurate knowledge of the thickness of thermally insulating scale on the inside of boiler tubing. In order to determine this thickness in nondestructive way, ultrasonic method proved to be most useful. However, first uses of this diagnostic tool done over a decade ago were cumbersome as they involved recording the amplitude-time (A-Scan) profile. The time sections of these A-Scans representing reflection from the tube inner surface were analyzed for the presence of two overlapping reflections. The first reflection comes from the interface between the tube-metal and the internal-oxide layer (if there is an internal oxide layer) and the second from the oxide-air interface (or the oxide-water interface if the measurements are made in-situ when the firebox is open for inspections during routine maintenance). The analysis of such indications was a very time-consuming and difficult process. However, as enough experience was gained, it was demonstrated that such measurements provided very useful information related to projecting when and where boiler tube failures might occur. This, in turn, provided the commercial incentive to develop a fast and reliable means to improve the inspection method. Specifically, few ultrasonic testing companies had developed a transducer and embedded software for their instruments, which now enables an internal oxide thickness measurement to be made quickly and accurately. Investigations performed within this project, were done using the Olympus 38DL hand-held instrument with transducer M2017, operating on 20 MHz frequency with a delay line. According to manufacturer, this system can measure internal oxide layers down to a minimum thickness of approximately 0.2 mm. In order to measure thinner scale, the Olympus Company offers a specialized M2091 transducer, which is a 20 MHz shear wave probe, to measure the scale down to 0.1 mm. In all cases the coupling surface must be clean and smooth and liquid couplant must be applied. Prior to measurements, the instrument has to be calibrated on scale with known thickness; such calibration reading is shown in Fig. 7.

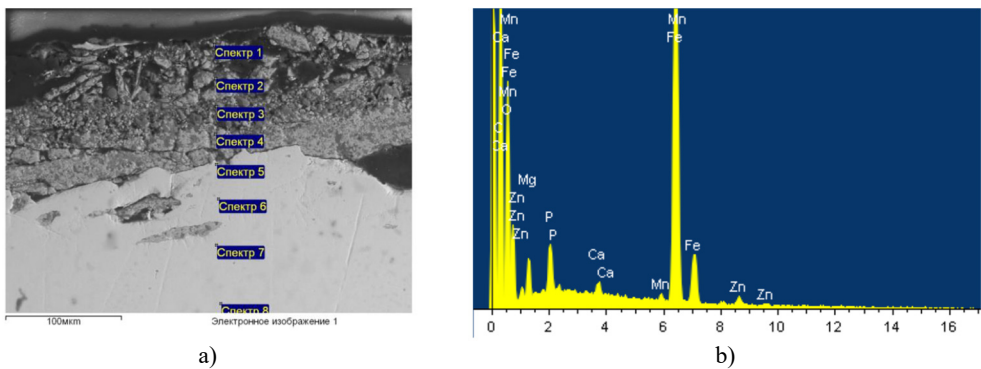
Max thickness of internal scale: 140 microns

Location	O	Mg	Si	P	Cl	Ca	Mn	Fe	Cu	Zn
C1	24.68	3.83		3.02		0.71	0.83	64.10		2.83
C2	27.20	2.10		2.82	0.48	2.83		42.90	18.37	3.31
C3	30.76	0.88		14.03		29.59		21.55	0.93	2.26
C4	35.24	13.50		6.94		1.11	0.68	32.05	0.87	9.62
C5	9.87	1.77	0.42	1.21		0.68	0.73	83.65		1.68
C6		0.53	0.38					98.25		0.84
C7							0.76	99.24

Fig. 8. Microscopic and spectral analysis of internal scale in Steel20

The chemical analysis of internal scale did not identify the magnetite as the only ingredient and pointed to strong possibility of other compounds such as phosphates and carbonates (the latter especially in Cr-Mo steel). Further, presence of Al and Si may indicate some additional ingredients and therefore the thermal conductivity of the scale maybe quite different than that for pure magnetite. For that reason, the results of previous references and in particular Eq. (3) may not be fully applicable to local conditions in Central Asia. It is recommended that in order to evaluate the creep damage based on measurement of internal scale thickness, one will take more conservative approach than used generally in western countries.

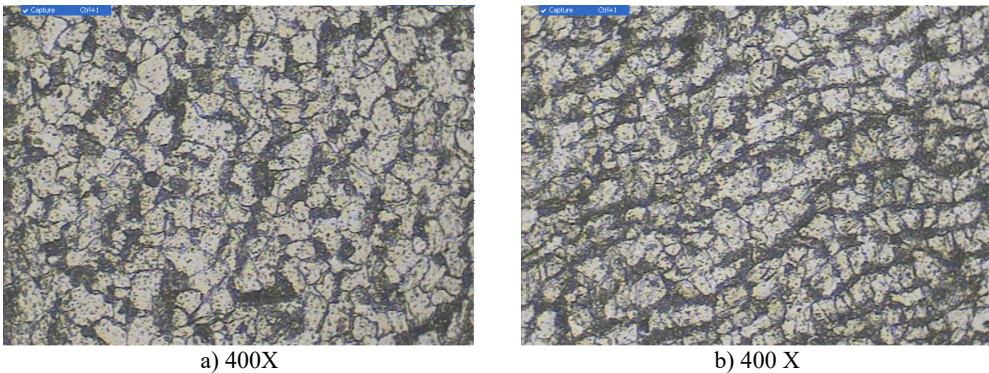
Fig. 9. Metallographical structures for Steel 20. Sample without presence of internal oxide a) and with oxide scale approx. 150 micron thick b). Ferritic-pearlitic structure observed in both samples with occasional inclusions in ferrite grains. Sample on the (b) differs slightly by enlarged and elongated grains, indicating the initiation of structural degradation – classified between Stage B and C on Toft and Marsden scale [18] (note that this scale was developed for Cr-Mo steels and not for low carbon steels)

The above results have shown that creep analysis based on the thickness of internal oxide scale for Steel20 has to be more conservative than literature recommendations developed for Cr-Mo steels. Fig. 9 indicated creep initiation with only minor internal scale (150 microns), which according to previous research could be easily ignored.

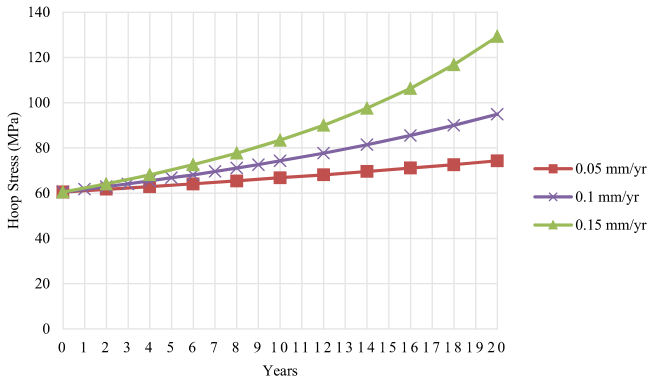
Fig. 10. Hoop stress growth in boiler tubes as a function of thinning rate

where b_0 is an initial (nominal) wall thickness and t is time. An exemplary graph of hoop stress for various rates of thinning is shown in Fig. 10 below. All calculations were made for Steel20 tube of 50 mm diameter, 6 mm wall thickness at saturation pressure of 16.5 MPa.

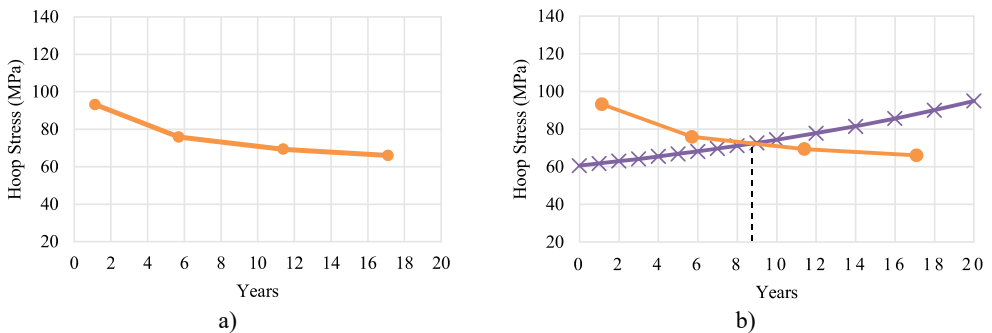
Fig. 11. a) Hoop stress as a function of time-to-failure for exemplary case of tube overheated to 470°C and b) the same curve with superimposed graph of hoop stress as a function of wall thickness at steady thinning rate of 0.1 mm/yr. The tube remaining life is read on intersection of both curves; in example above, less than 9 years

4. Using data from Table 2, create a graph of a hoop stress as a function of time-to-failure as shown in Fig. 11(b). Authors, usually show this graph in service hours, but for simplicity, Fig. 11 shows it in full years of service, assuming 1 year = 8760 hrs.
5. On the same scale, superimpose the graph for hoop stress as a function of time for a thinning rate determined by periodic EMAT tests (as in Fig. 10). The estimated remaining tube life is then determined on the intersection of both curves as shown in Fig. 11(b) (example for 0.10 mm/yr thinning rate). It needs to note, that the above analysis should be repeated and curves updated each time new NDT data are available - usually during each maintenance shutdown.
