Detection method for underwater dock joints: underwater sonar imaging based on 3D technology

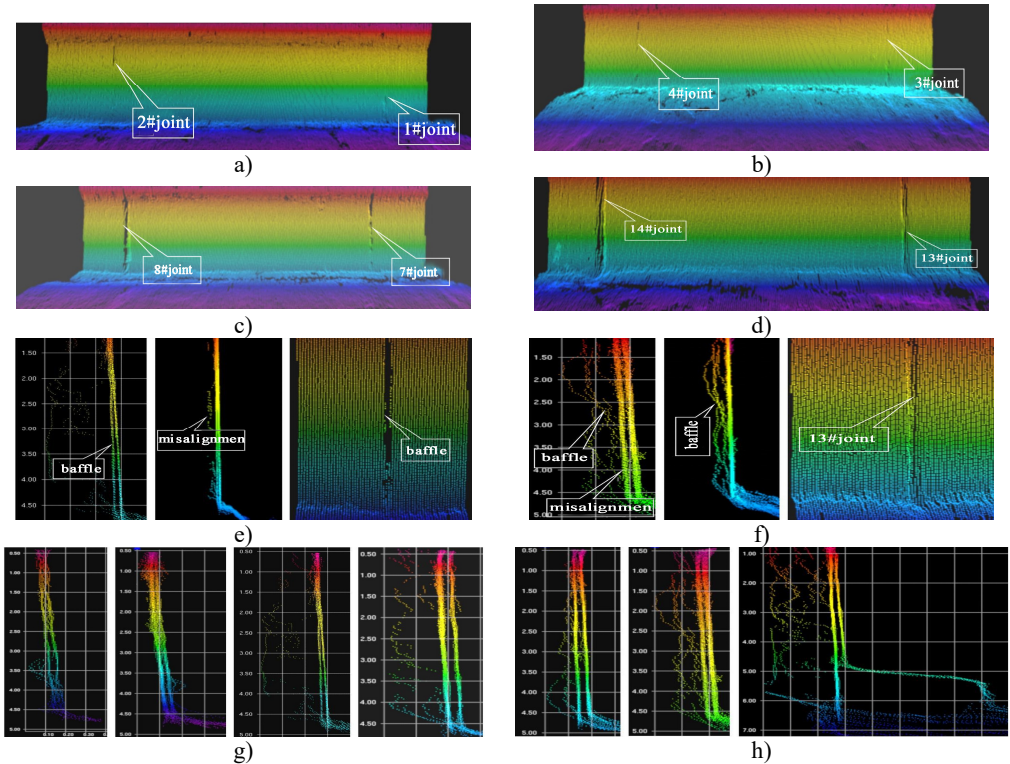
Joints of caissons are shown in Figs. 9(a)-(f), and misalignment in caissons are shown in Figs. 9(g)-(h). From Figs. 9(a)-(d), it can be observed that the widths of each joint are small, all less than 80 mm.

From the front view in Fig. 9(e), joint 8# shows a widening from top to bottom (widths of

40 mm at the top and 210 mm at the bottom) with an angular displacement of approximately 1.5°. From the side view, the joint exhibits a two-section insert plate extending 3 m high (from 1 to 4 m from the theoretical depth reference) with misalignment. From the front view in Fig. 9(f), joint 13# shows a widening from top to bottom (widths of 80 mm at the top and 150 mm at the bottom) with an angular displacement of approximately 1°. From the side view, the joint features a 6.5 m high insert plate (from –2 to 4.5 m from the theoretical depth reference).

The allowable range for caisson installation joint width is from 50 mm to 110 mm. A total of 25 joints were randomly sampled for testing, among which 11 had widths less than 50 mm and 6 exceeded 110 mm. The upper joints of caissons 10#, 14#, 15#, 19#, and 25# are wider, while the lower joints of caissons 19# and 25# are narrower, showing a widening from top to bottom, with uniform upper and lower widths for the remaining joints. The visual inspection of the detection images indicates that the boundaries of each joint are relatively regular, without damage. Adjacent mismatches of caissons near the water surface and lower parts were randomly sampled for 30 joints, with 15 exceeding 30 mm. Tables 4-5 summarize the caisson joint width detection and adjacent caisson mismatch statistics.

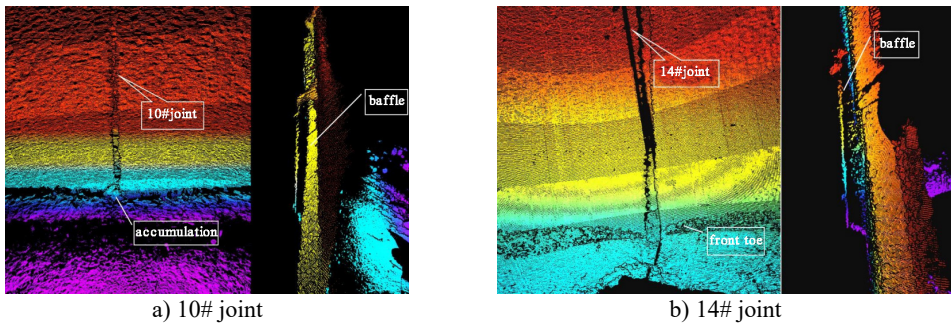
a) 10# joint   b) 14# joint
Fig. 10. 3D scanned front view and side view of joints

The multi-beam bathymetry system detected that joints 10#, 14#, 15#, 19#, and 25# had larger widths. Further detailed scanning and magnified detection were conducted using three-dimensional imaging sonar, and some scanning images are shown in Figs. 10(a)-(b). The detection results indicate that joints 10# and 14# have larger widths, with uniformly wide upper and lower joints and higher insert plates. Joint 10# also shows a small accumulation at the bottom. Joints 15# and 16# of the high-low caissons connections are wider with even upper and lower widths, and the front toe of caisson 15# is prominent. Joints 19# and 25# are less obvious, showing a widening from top to bottom, with joint 19# featuring an insert plate in the upper half.
