1046. Blades rubs and looseness detection in gas turbines – operational field experience and laboratory study

Leong M. S.¹, Lim Meng Hee²

¹Institute of Noise & Vibration, Universiti Teknologi Malaysia, Malaysia

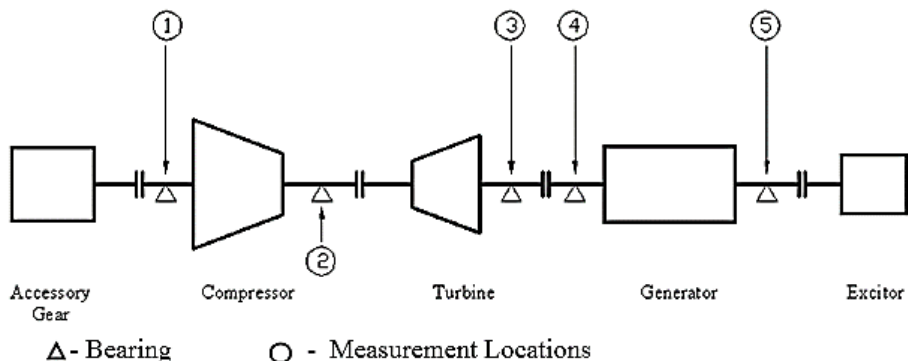
This case study was for a 110 MW in a gas turbine turbo-generation set in a Malaysian power plant. Fig. 1 illustrates a schematic diagram of the 110 MW gas turbine turbo-generation set. Steady but significant increases in the OEM's casing overall vibration levels were noted from the monitoring system fitted for the unit. Initial concerns and diagnosis by the plant and vendor focused on probable rotor unbalance, which included trim balancing works in an attempt to reduce the vibrations. Such efforts however did not yield meaningful reduction. (This was several months before the cracked shaft was detected).

Fig. 1. Schematic diagram of a 110 MW gas turbine turbo-generation set

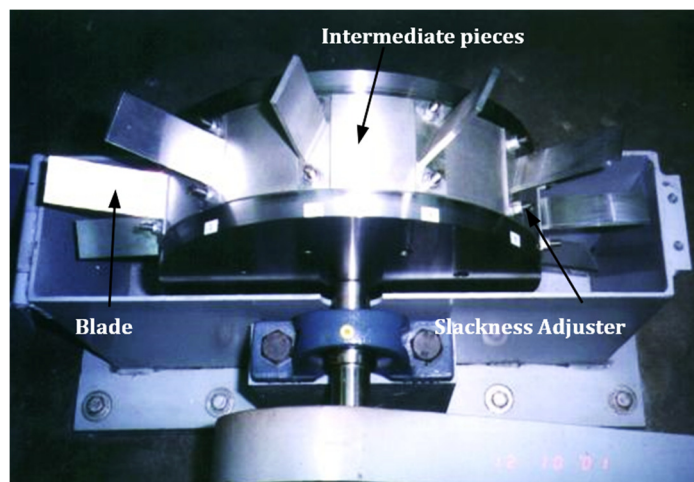
Experimental studies (see the experimental rig in Fig. 9) were undertaken to simulate loose blades condition (at the attachment points that typically replicates conditions in some gas turbines) to provide a better understanding on characteristics of loose blades under different operating conditions. Details of the study and test conditions are given elsewhere (Lim and Leong [15]). Test configurations included baseline no fault conditions, single and multiple loose blades, and random loose blades with varying degrees of looseness. Results of the experimental study under various controlled conditions showed that loose blades were undetectable under steady state operating conditions (constant speed) presumably due to centrifugal action forcing the loose blades into a “locked position”. It was during rotor coast downs that looseness in the blades was detectable based on the series of impact signals generated by the loose blades exciting natural frequencies of the rotor system. Results from the coast down condition showed that wavelet analysis was more sensitive and effective than Fourier analysis for loose blades detection. The severity, number and configuration of the loose blades could be potentially estimated based on the pattern of the coast down wavelet map.

Fig. 9. Photograph showing test rig with blade assembly and intermediate locking pieces

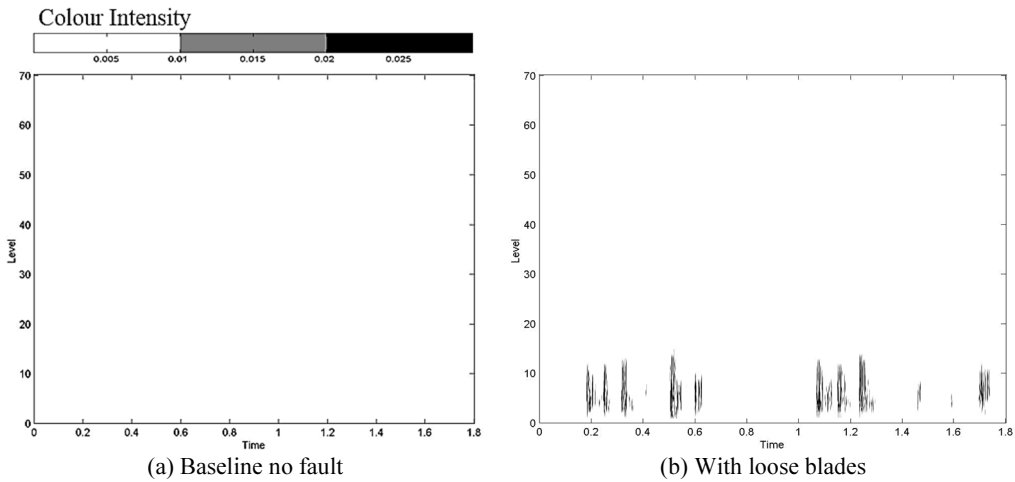
Fig. 11. Wavelet maps without and with loose blades

Fig. 10 shows a cascade plot of FFTs spectra as the rotor coast down from operating speed to stationary conditions. The plots showed no discernable differences that suggested any abnormality in the vibration response between no fault conditions with the case having induced blade looseness. In the baseline condition (no fault), the coast down wavelet map was clean, Fig. 11a. Fault conditions with blade looseness showed distinct changes in the coast down wavelet, Fig. 11b. Looseness severity, the number of loose blades, as well as configuration of the loose blades governed the time duration of consecutive impacts and severity level of the wavelet maps. This finding was in good agreement with the finding of Aretakis et al [7] that the wavelet analysis allows local features and hidden details of a signal to be identified that may make it useful for condition monitoring when detection of small dynamic changes is important.
