Dependence of damage to the running surface of the railway rail on the vibroacoustic signal of a passing passenger train

Abstract. The article presents an extended summary regarding the impact of rail damage on vibration waveforms and vibroacoustic spectrum images of vibrations. The analyzed example is based on the passage of the train depot – passenger train on a selected railway line. A short summary of the analyzed research problem is also presented.

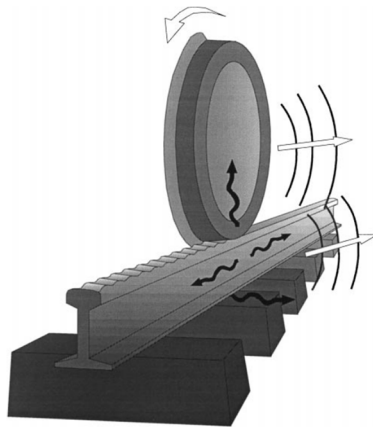
Fig. 1. Schematic diagram of how rolling noise is generated by the wheel/rail interaction and radiated by the wheel, the rail and the sleepers [9]

There are two basic types of structural vibration: steady-state vibration caused by continually running machines such as engines, and transient vibration caused by a short-duration disturbance such as train passing over an expansion joint in a rail. The major source of railway rolling vibration is the structural vibration of the wheel and rail which is generated by the combination of small-scale undulations on the wheel and rail contact surfaces.

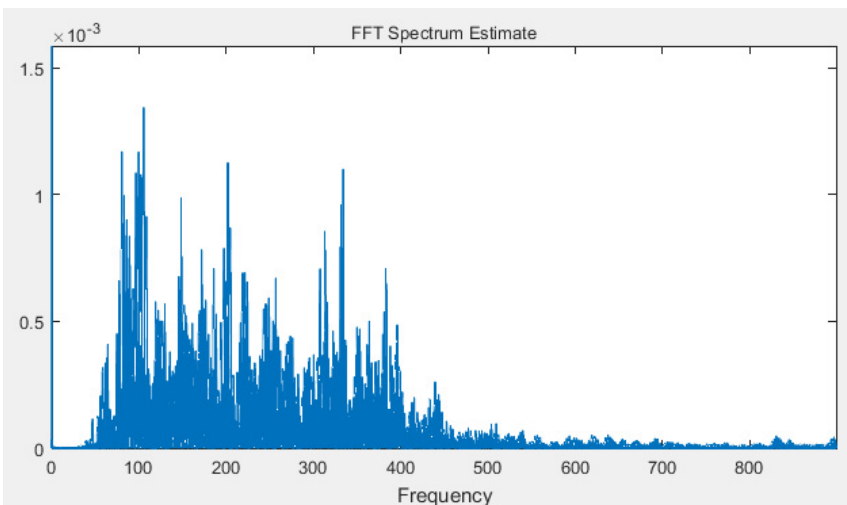
Fig. 4. Spectral analysis of signals – signal from sensor Ai2

Fig. 3. A comparison of two waveforms for the sensor Ai2 (blue color) and Ai3 (purple color) is presented. Differences in amplitude for the two signals can be seen. In contrast, Fig. 4 and Fig. 5 show FFT Spectrum Estimate and for the signal from the sensor Ai2 a gain for frequencies from 50 Hz can be observed, decreasing until reaching 500 Hz. In the case of the signal from the Ai3 sensor the situation is different, and the amplification of the signal takes place around the frequency of 4000 Hz.

The results, despite the slight damage to the rail, indicate a large difference in signal waveforms as well as in the image of the signal spectrum. It notices the amplification of the signal from the Ai3 sensor located near damaged place where the frequency oscillated around 4000 Hz, while the spectral analysis of the signal for the Ai2 sensor located 5.4 m away to the damage indicates oscillating values in the range from 50 to 500 Hz.
